**WLB3 - Replacing Ground Point for External Power Connection (Workshop Campaign)**

Model line: **Taycan (Y1A)**

Subject: **Ground point for external power connection**

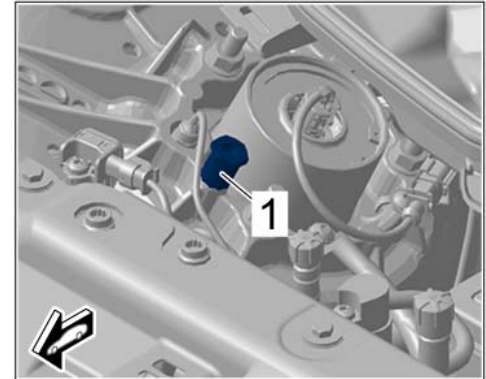
*Removing ground screw*

Do not create stress or damages to the plastic pneumatic line for the right front air shock assembly during the replacement procedure!

Do not allow the plastic pneumatic line for the right front shock assembly to be in contact with the charge post, or the external charger cable clamp, during any 12 Volt Battery charging operations. The normal subsequent heat generated at this charge point connection can permanently damage the plastic pneumatic line.

2 Loosen and unscrew old ground screw ⇒ *Removing ground screw-1-*.
