Service Alert

Subject: REAR BACKUP CAMERA IS INOPERATIVE OR DISPLAY IS DISTORTED	Service Alert No.: SA-038/20
	Last Issued: 04/08/2020

2014-2018 Mazda3 (5-door)

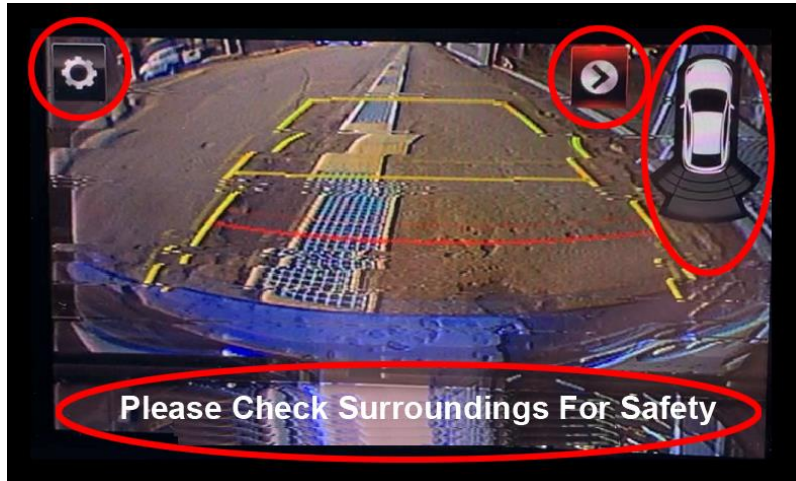
Some customers may complain about a rear view monitor display that is:

- Blank (or may have backup camera warning message)
- Distorted
- Blurry
- Fuzzy
- Split screen (see attached video)
- Grainy

The icons and text are normally displayed.

1. Verify customer concern.
2. Does the instrument cluster show "R" when in reverse? (Except M/T vehicle)
 - Yes - Proceed to the next step.
 - No - This service information does not apply. Proceed to MGSS for troubleshooting.
3. Is the display split, fuzzy or distorted and the icons and text are normally displayed? (see Description image)
 - Yes - Proceed to next step.
 - No - This service information does not apply. Proceed to MGSS for troubleshooting.
4. Is CMU DTC B12BD11 (Rear mount camera circuit malfunction) stored?
 - Yes - Go to MGSS DTC B12BD:11 [CONNECTIVITY MASTER UNIT].
 - No - Replace the Rear Camera.
5. If possible, take a photo or video of the concern.
6. Verify repair.
