# Service Alert

<b>Subject:</b>  FORWARD SENSING CAMERA (FSC) DYNAMIC AIMING NOT COMPLETED AND/OR DTC B14F0:76 STORED	<b>Service Alert No.:</b> SA-046/20
	<b>Last Issued:</b> 04/14/2020

2019 - 2020 MAZDA3  
2020 CX-30

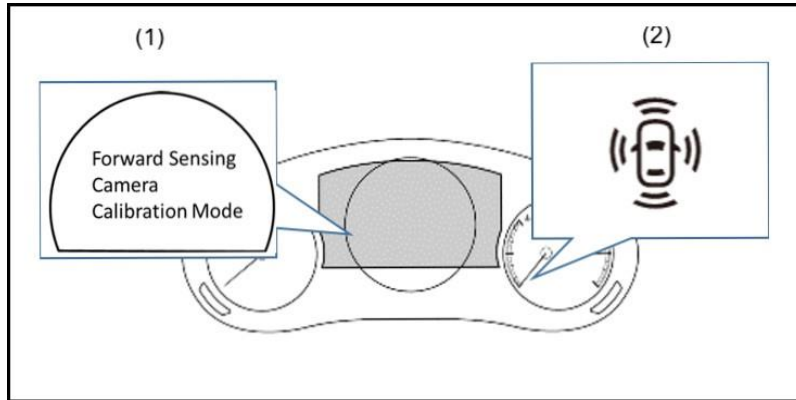
FSC dynamic aiming is completed if the following conditions are met:

1. "Forward Sensing Camera Calibration Mode" message (1) on instrument cluster MID disappears.
2. The i-ACTIVSENSE warning light (2) turns off.
3. Steps 1 and 2 are completed within 20 minutes from start of aiming.
