Service Alert

Subject: CRACKED REAR DIFFERENTIAL CASE FOUND ON NEWLY DELIVERED VEHICLES	Service Alert No.: SA-047/20
	Last Issued: 04/28/2020

2017-2020 CX-3 AWD
2017-2020 CX-5 AWD
2017-2020 CX-9 AWD

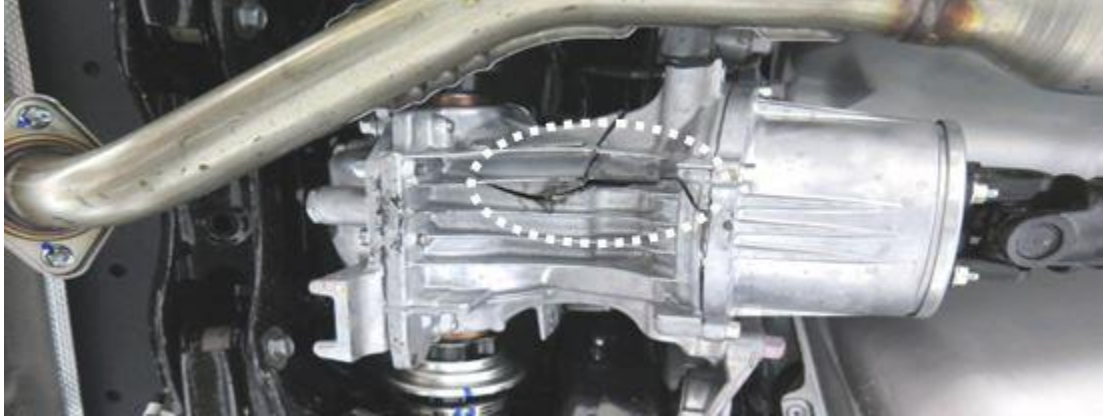
Be aware that some new AWD vehicles have been found with cracked rear differential cases, as shown below.

NOTE: This may affect new vehicles just delivered to the dealer or new vehicles in dealer inventory.

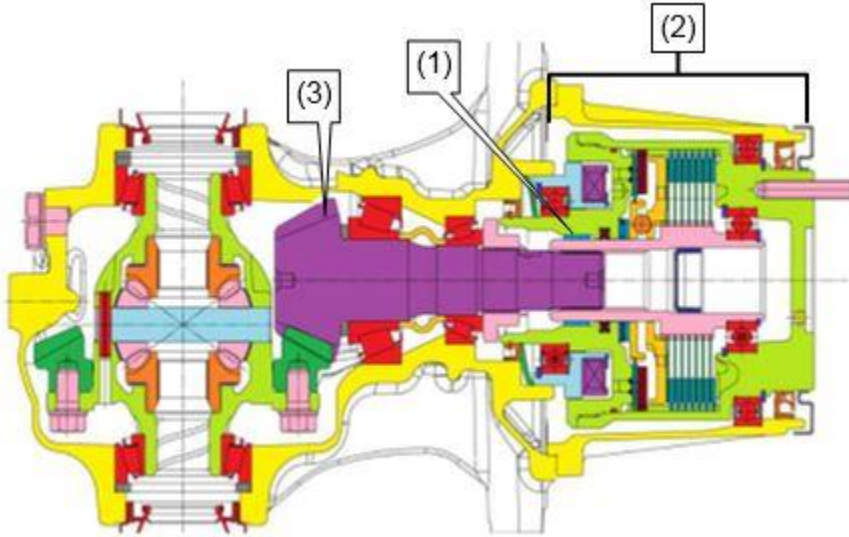
This concern is caused when the sliding bearing (1) in the coupling (2) is seized and causes the coupling component to fit loosely. The pinion shaft head (3) then contacts the differential case and causes a crack.

NOTE: If a vehicle is left for a long period of time on a trailer with the front end lifted up, the oil in the rear differential unit flows to the rear and the sliding bearing may not receive enough lubrication. If the vehicle is started aggressively at that time, it may damage the sliding bearing.

1. Be sure to release the Electric Parking Brake (EPB) before starting the vehicle. If a vehicle is started aggressively with the EPB applied, higher torque and slippage may occur in the coupling component causing damage to the sliding bearing.

2. When unloading a vehicle from a trailer, a) be sure that all tire straps/bands are removed and b) avoid aggressive starting to prevent coupling slippage, which is caused by a large difference of rotation between the front and rear wheels.
