Subject: ENGINE NO START WITH DTC B13D3:97 STORED DUE TO ACTIVATION OF PACEMAKER FUNCTION	Service Alert No.: SA-048/20
	Last Issued: 04/28/2020

2019-2020 Mazda3
2020 CX-30

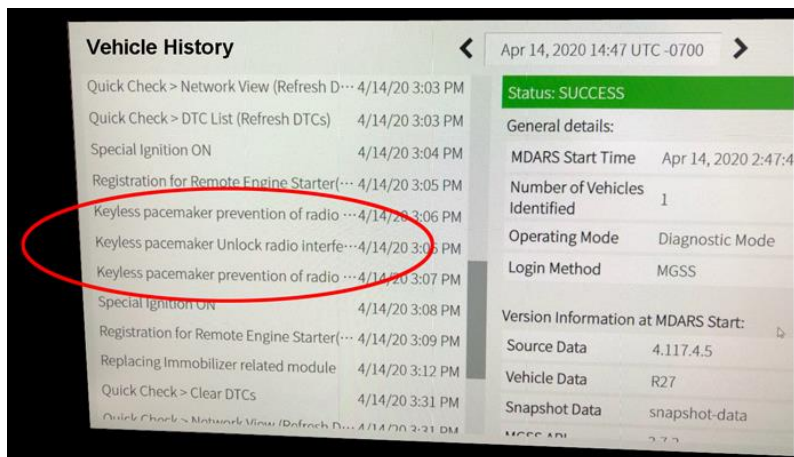
Example of Keyless Pacemaker Function activated:

- Yes - Deactivate the Keyless Pacemaker Function.
