Popping or Crackling from the Speakers? Check the MOST Bus Network

Year	Model	Trim
2018- 20	Odyssey	ALL except LX
2019- 20	Passport	ALL except Sport
2019- 20	Pilot	ALL except LX

EDITOR'S NOTE: This article replaces the one posted in **December 2019**.

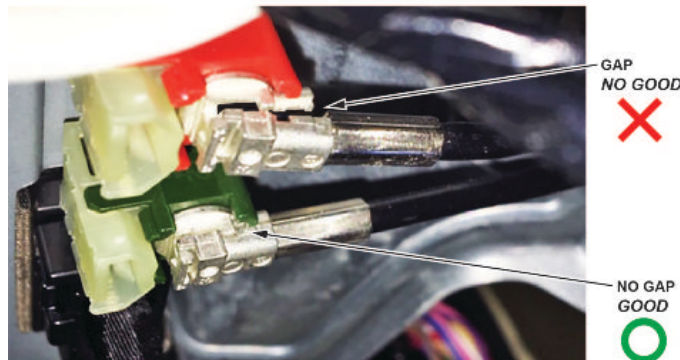
Be sure to inspect the red and green MOST connectors of all infotainment system components and any connections between the harnesses. If you find a damaged connector, like you see here, you must replace the entire harness. These connectors **are not** repairable.

When unplugging these connectors during inspection or replacement, never use the cables for leverage. You can easily damage the connectors.
