Technical product information

Topic	New Continental GT and New Continental GTC - Rear quarter glass not fully closing
Market area	Bentley: worldwide (2WBE)
Brand	Bentley
Transaction No.	2058424/2
Level	EH
Status	Approval
Release date

New Continental GT and GTC

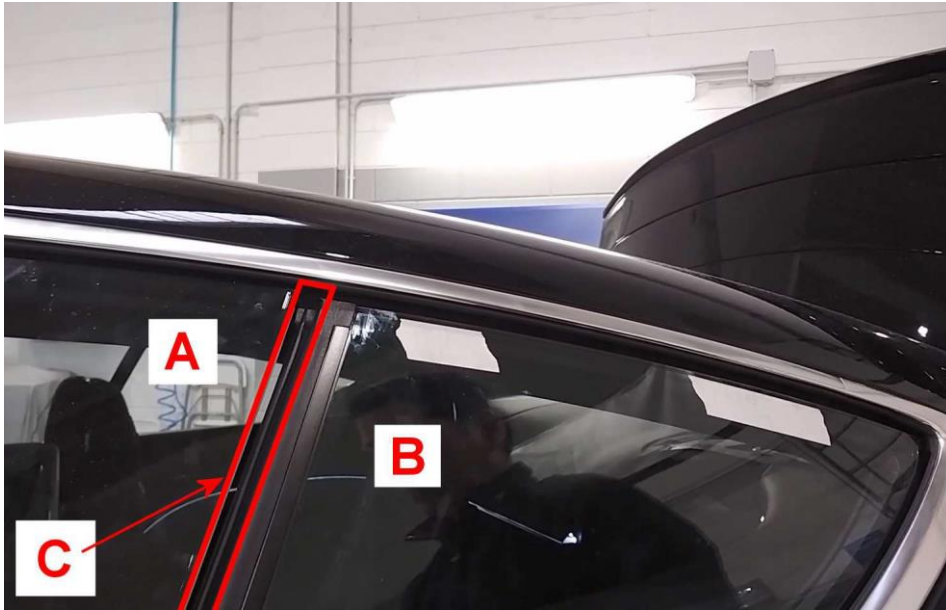
Referring to Figure 1 - During the window and/or door close operation, the front door drop glass closes and seals (Point A) however the rear quarter glass does not fully close and seal (Point B) leaving a gap between the front and rear glass (Point C)

Refer to the Measure section of this TPI

- 1) Ensure a suitable battery charger is correctly connected to the vehicle electrical system for the duration of this procedure
 - Switch on ignition, ensure the ignition is on for the duration of the update
 - Connect the Bentley approved diagnostic tool to the vehicle On Board Diagnostic (OBD) socket. NOTE: The process is Initiated via Bentley diagnostic tool (VAS6150C or similar) using a hard wire connection to the vehicle OBD socket, Bluetooth connections should not be used under any circumstances
