| Title | Mack Chassis - Equipped With A Turbo-Compound Engine ONLY - Engine Stumble At Idle/Low NOx Idle - US17+OBD18 And Newer Emissions |

| Cause | Certain Mack chassis equipped with a turbo-compound engine may experience an engine stumble or hiccup when sitting at idle or low-NOx idle. |

| Title | Volvo Chassis - Equipped With A Turbo-Compound Engine ONLY - Engine Stumble<br>At Idle/Low NOx Idle - US17+OBD18 And Newer Emissions |

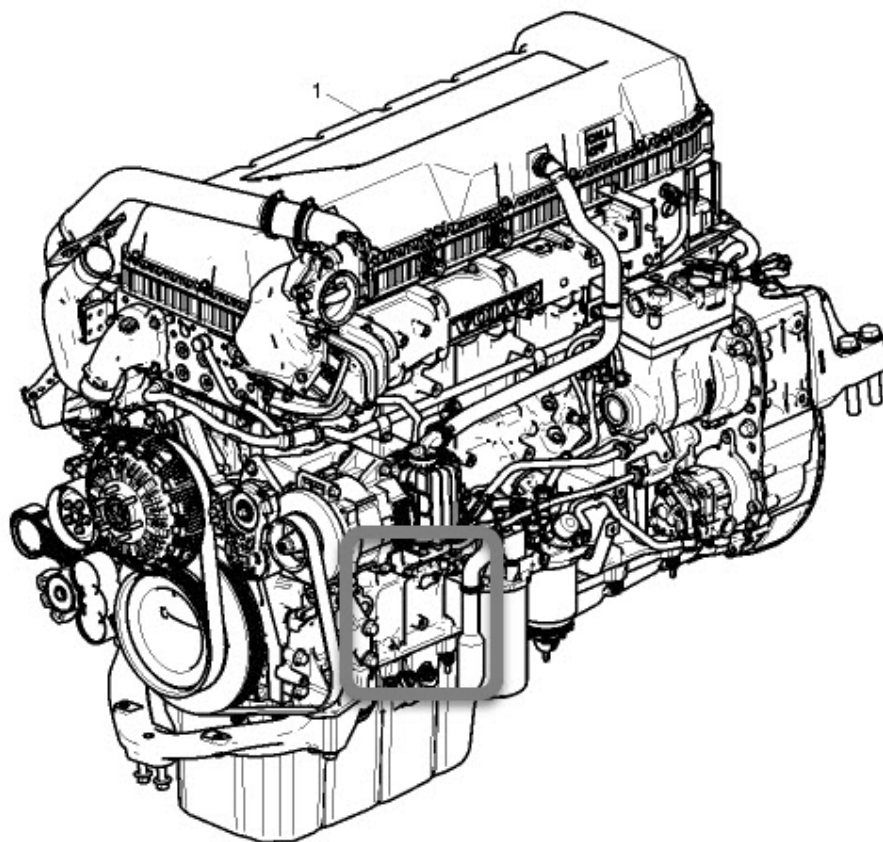
It has been determined that this condition may be caused by loss of air pressure to the Buffer Valve/Air Valve Units (BVU/AVU) due to incorrect plumbing of the air supply. The air supply to the Air Valve Unit (AVU) was found to come directly from the "wet" or supply tank Instead of the Tractor Protection Valve as shown in purple below:

3. Replumb the air supply to the AVU/BVU as indicated in the pictures above. A complete schematic of the pressure protected circuit can be found below. Click on the picture for a full-size image:

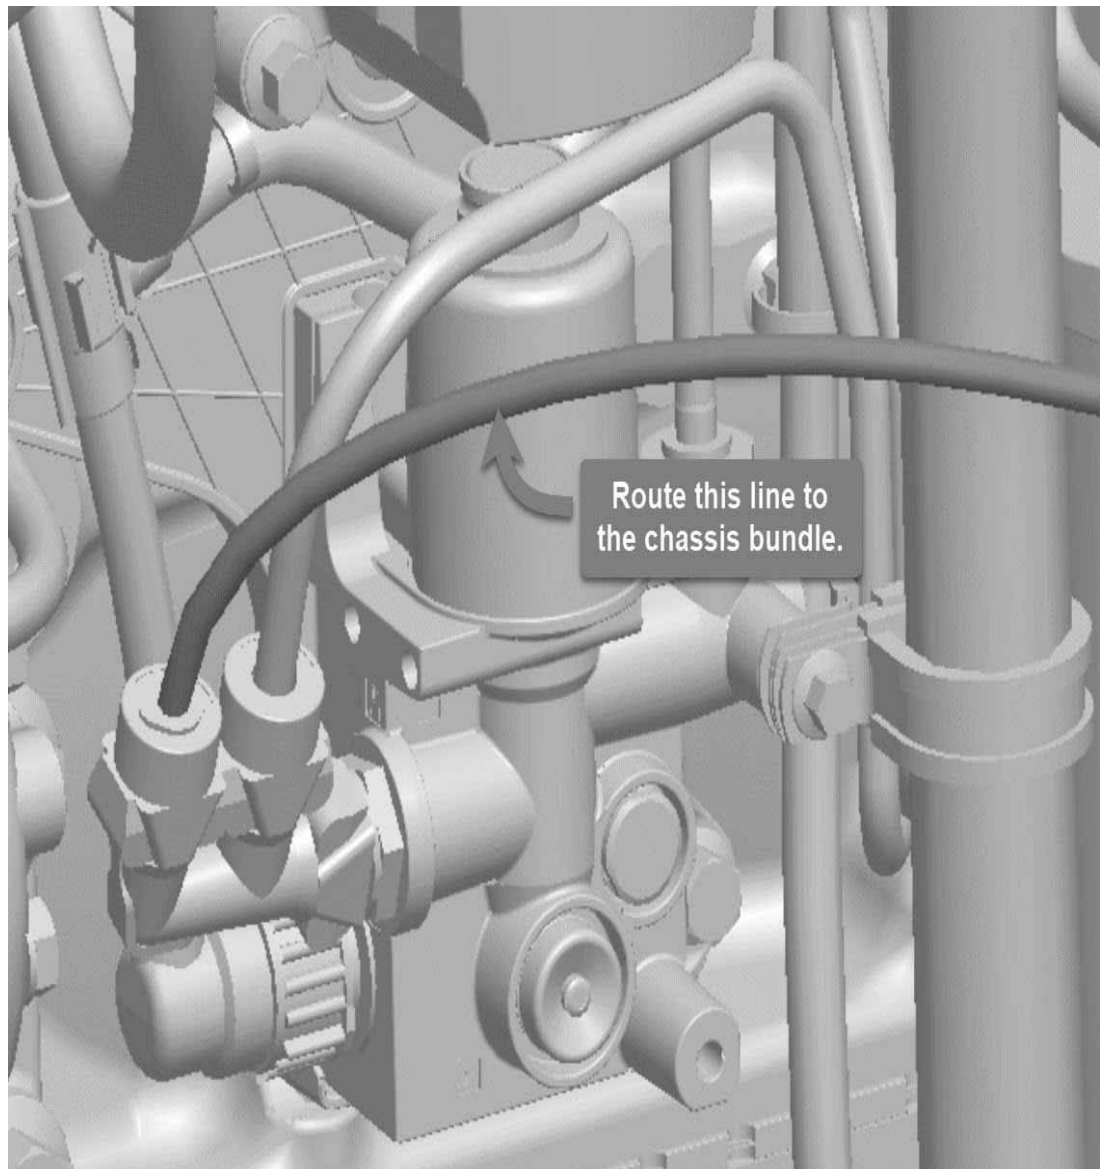
**1.1. Disconnect the AVU air line indicated in the picture below:**

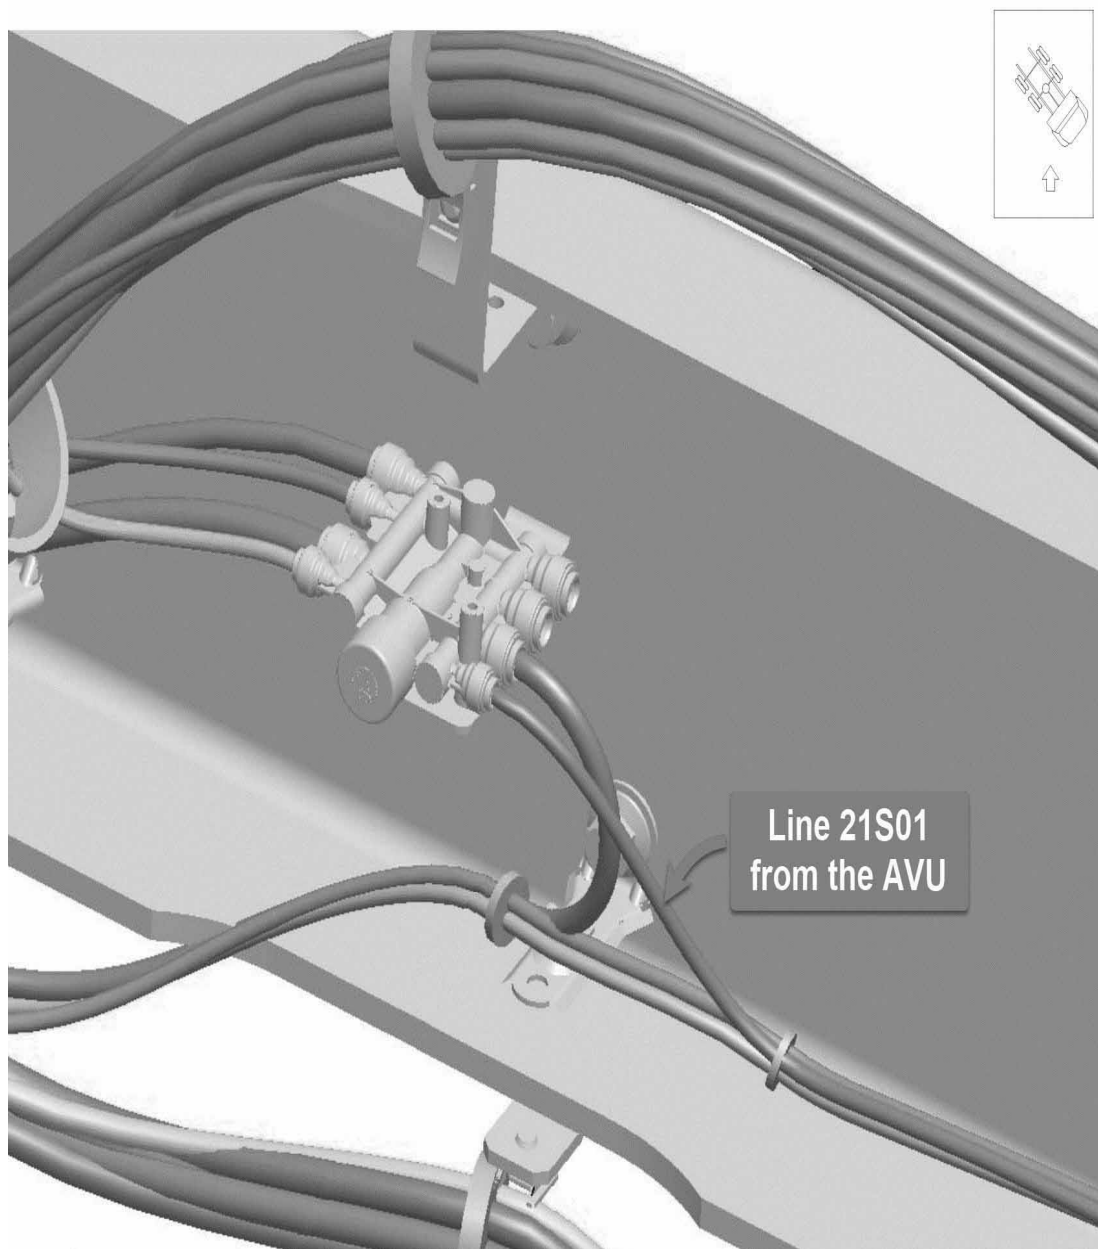
**1.2.** Disconnect the air line to the Pressure Protection Valve shown below:

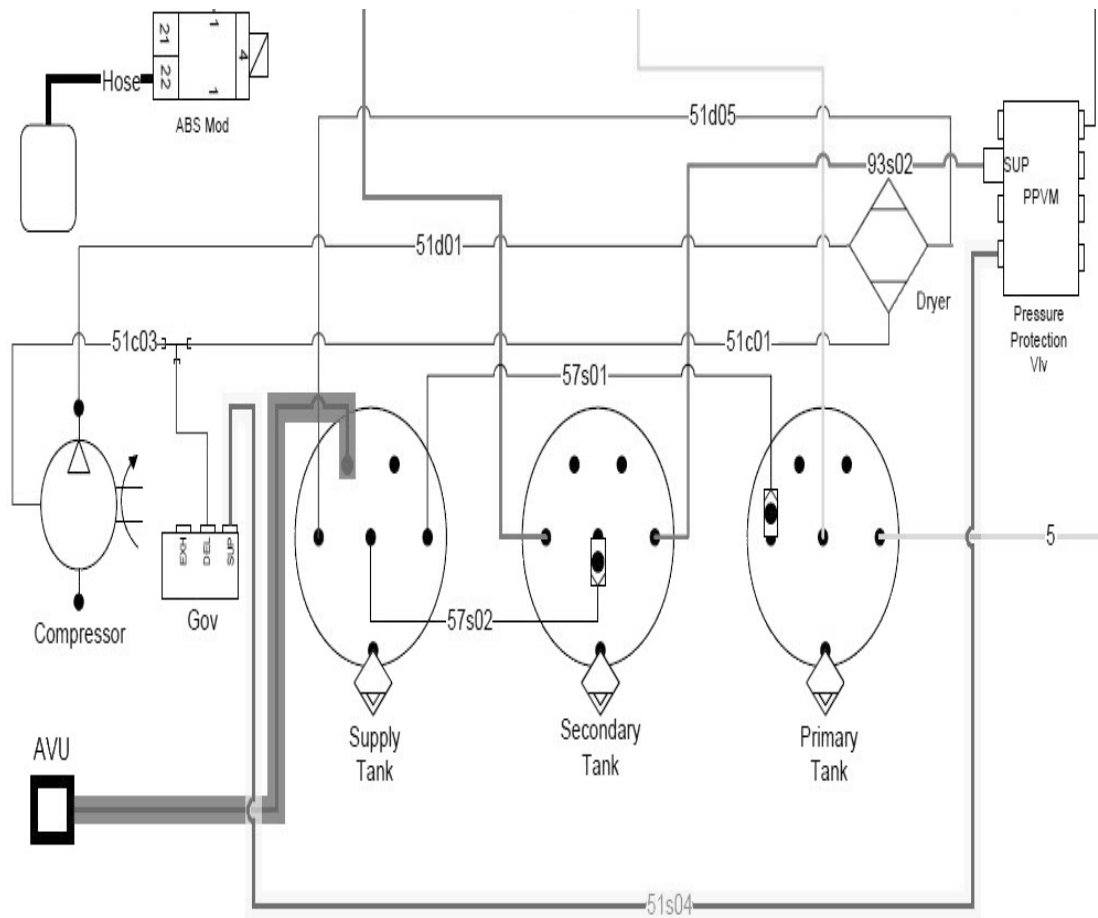
It has been determined that this condition may be caused by loss of air pressure to the Buffer Valve/Air Valve Units (BVU/AVU) due to incorrect plumbing of the air supply. The air supply to the Air Valve Unit (AVU) was found to come directly from the "wet" or supply tank Instead of the Tractor Protection Valve as shown in purple below:

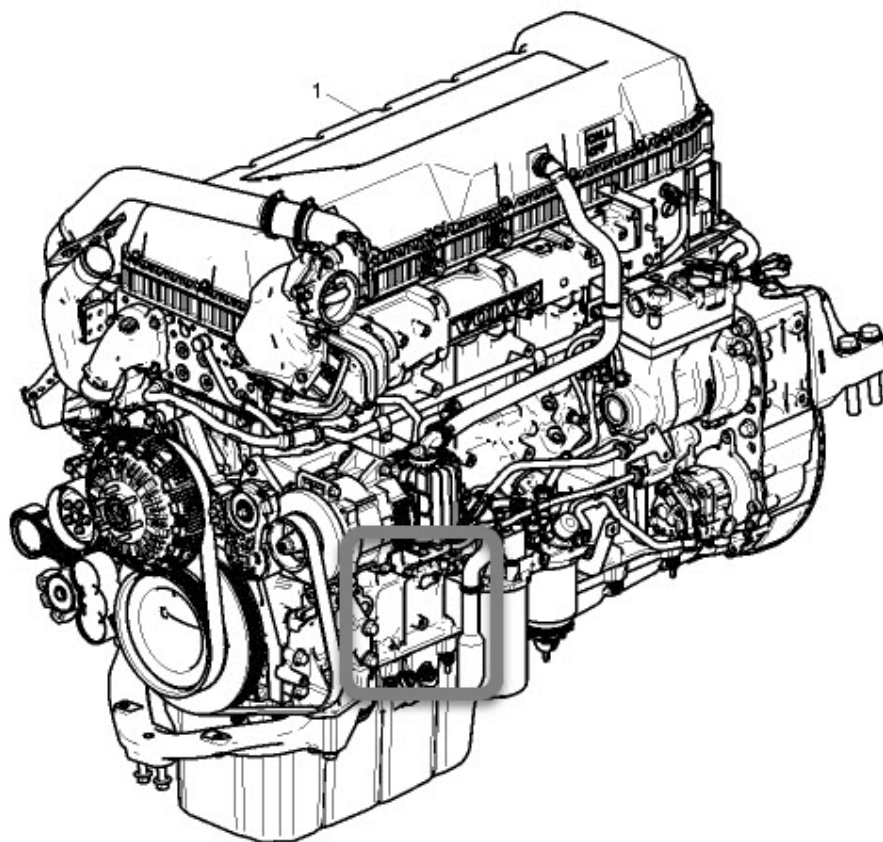
**The AVU is located in front of the fuel filter housing as shown in the picture below:**

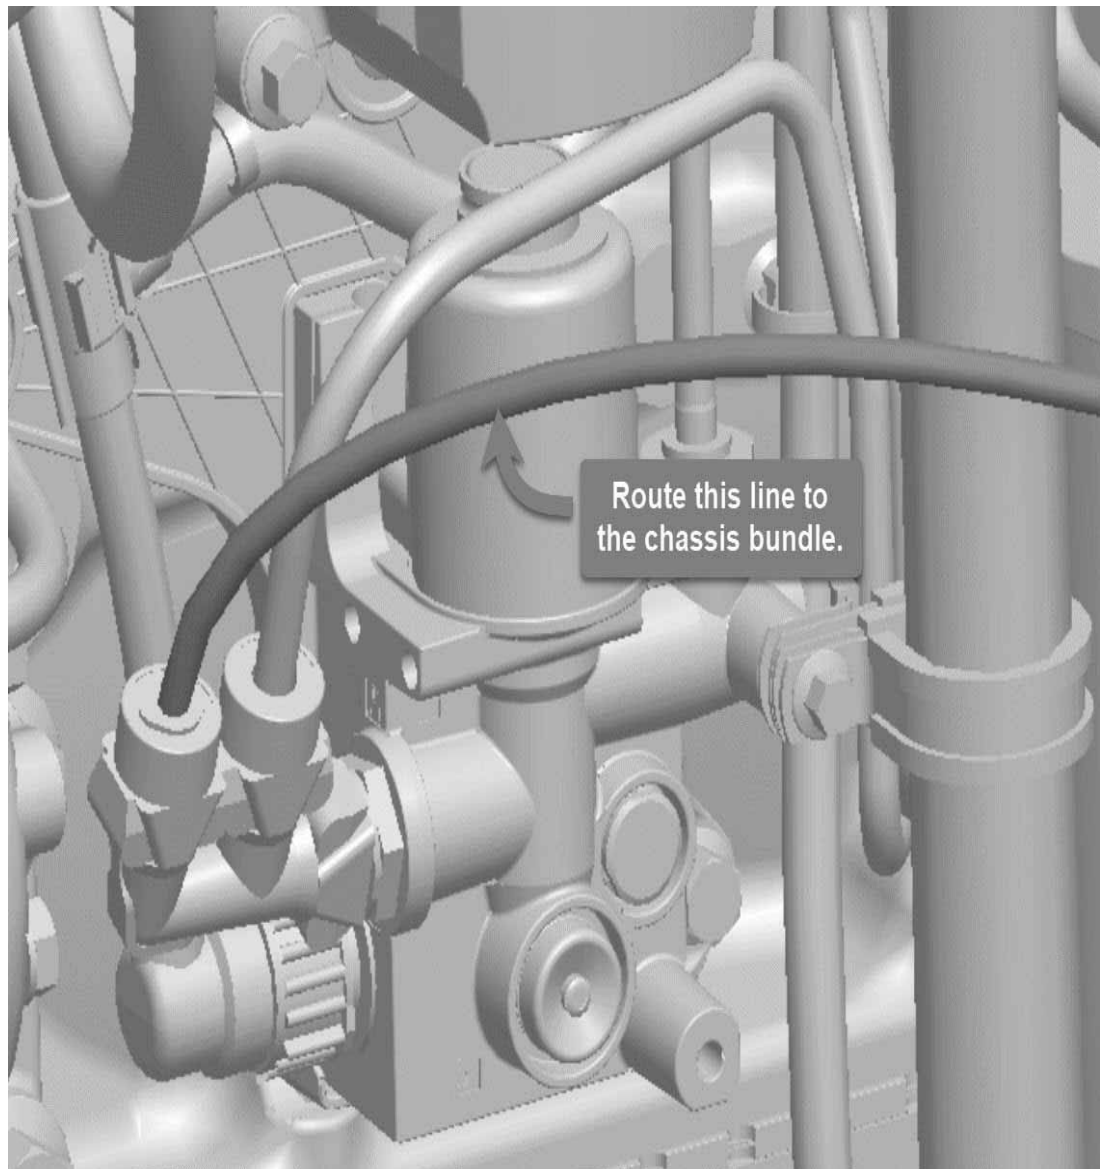
**1.1. Disconnect the AVU air line indicated in the picture below:**

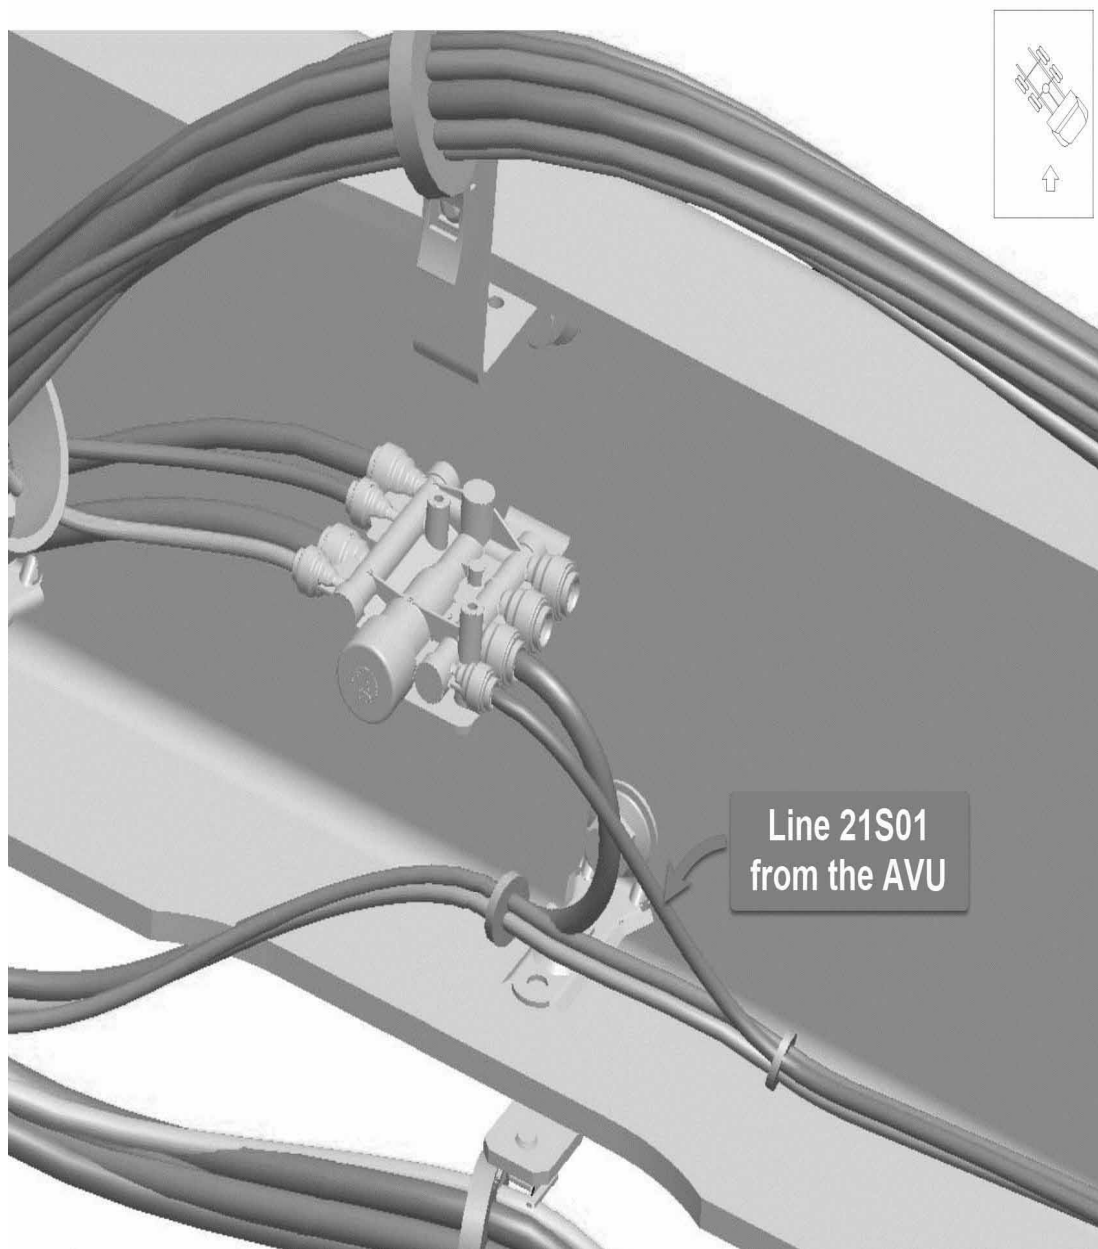
**1.2.** Disconnect the air line to the Pressure Protection Valve shown below:

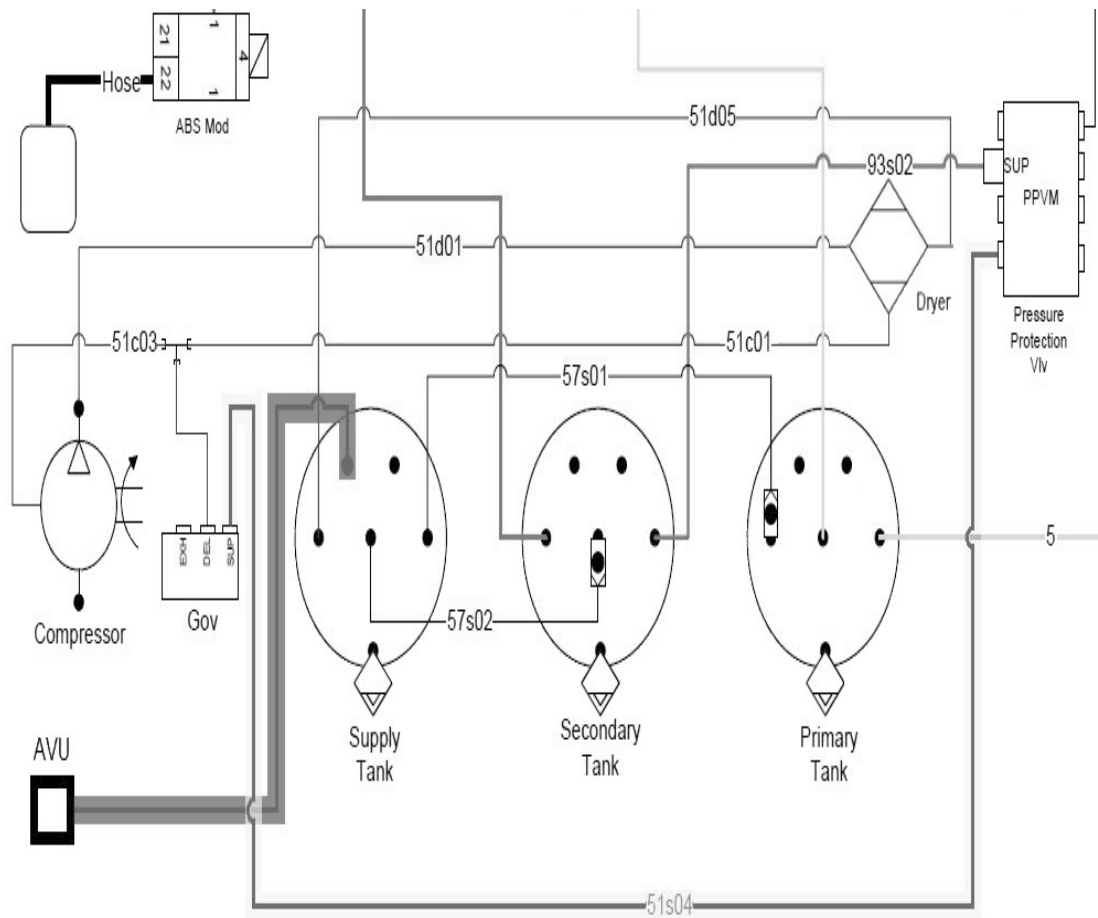
It has been determined that this condition may be caused by loss of air pressure to the Buffer Valve/Air Valve Units (BVU/AVU) due to incorrect plumbing of the air supply. The air supply to the Air Valve Unit (AVU) was found to come directly from the "wet" or supply tank Instead of the Tractor Protection Valve as shown in purple below:

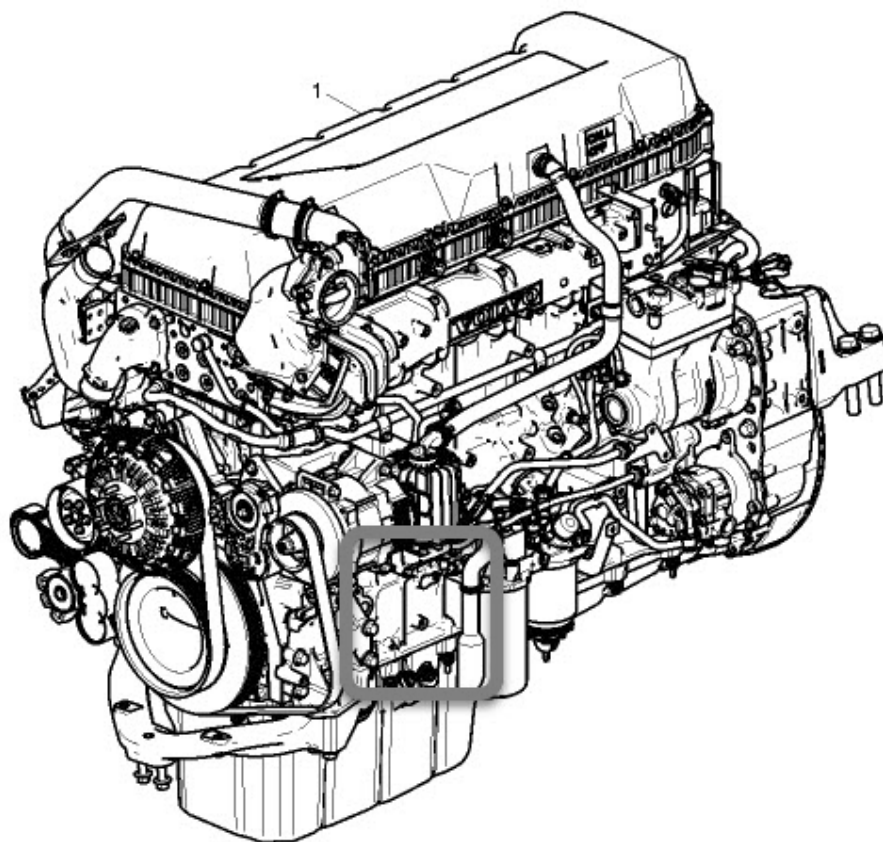
**The AVU is located in front of the fuel filter housing as shown in the picture below:**

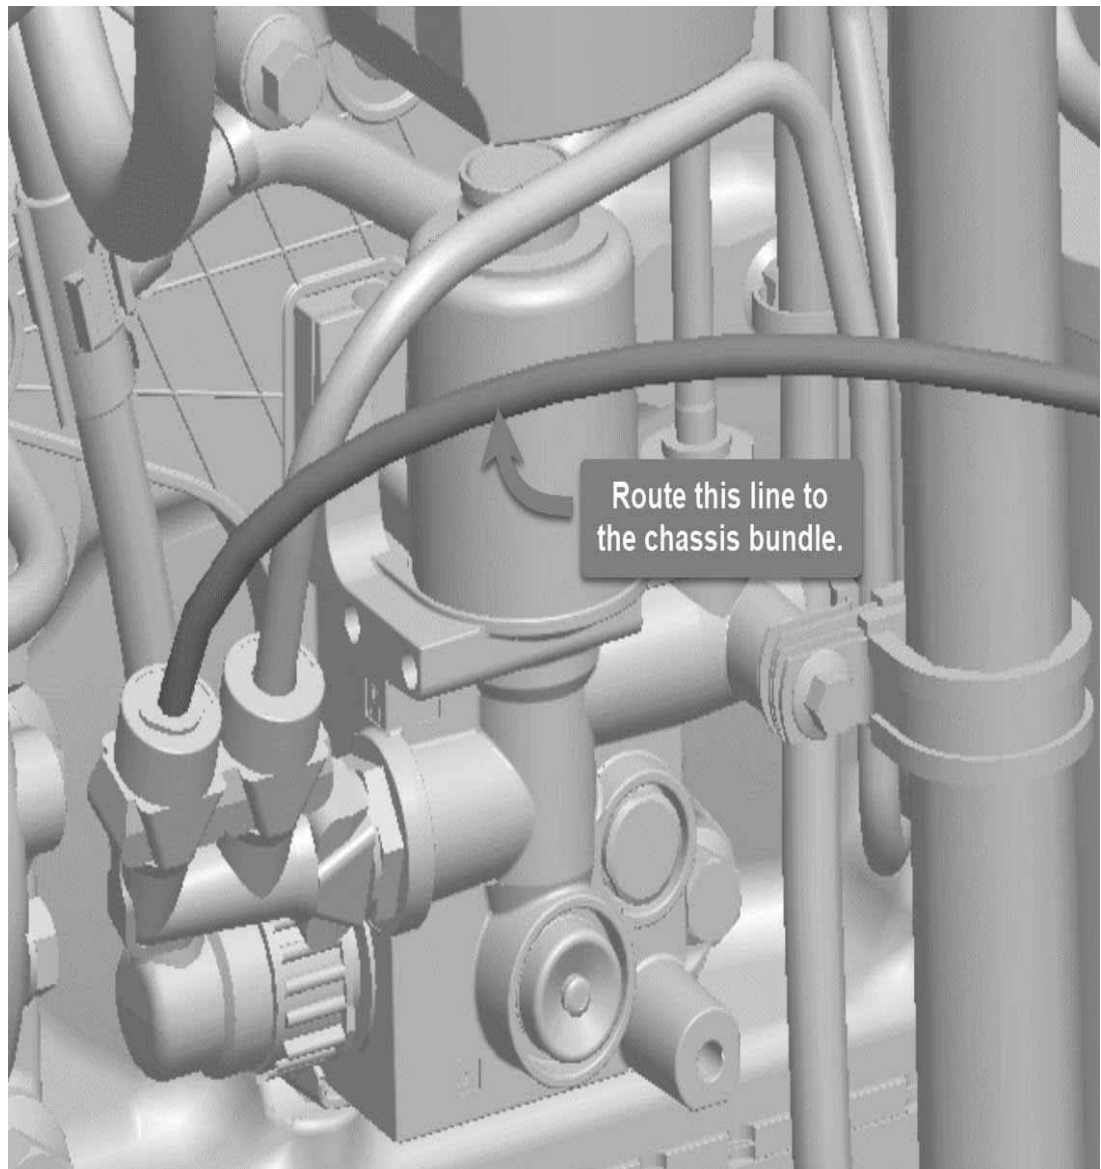
**1.1. Disconnect the AVU air line indicated in the picture below:**

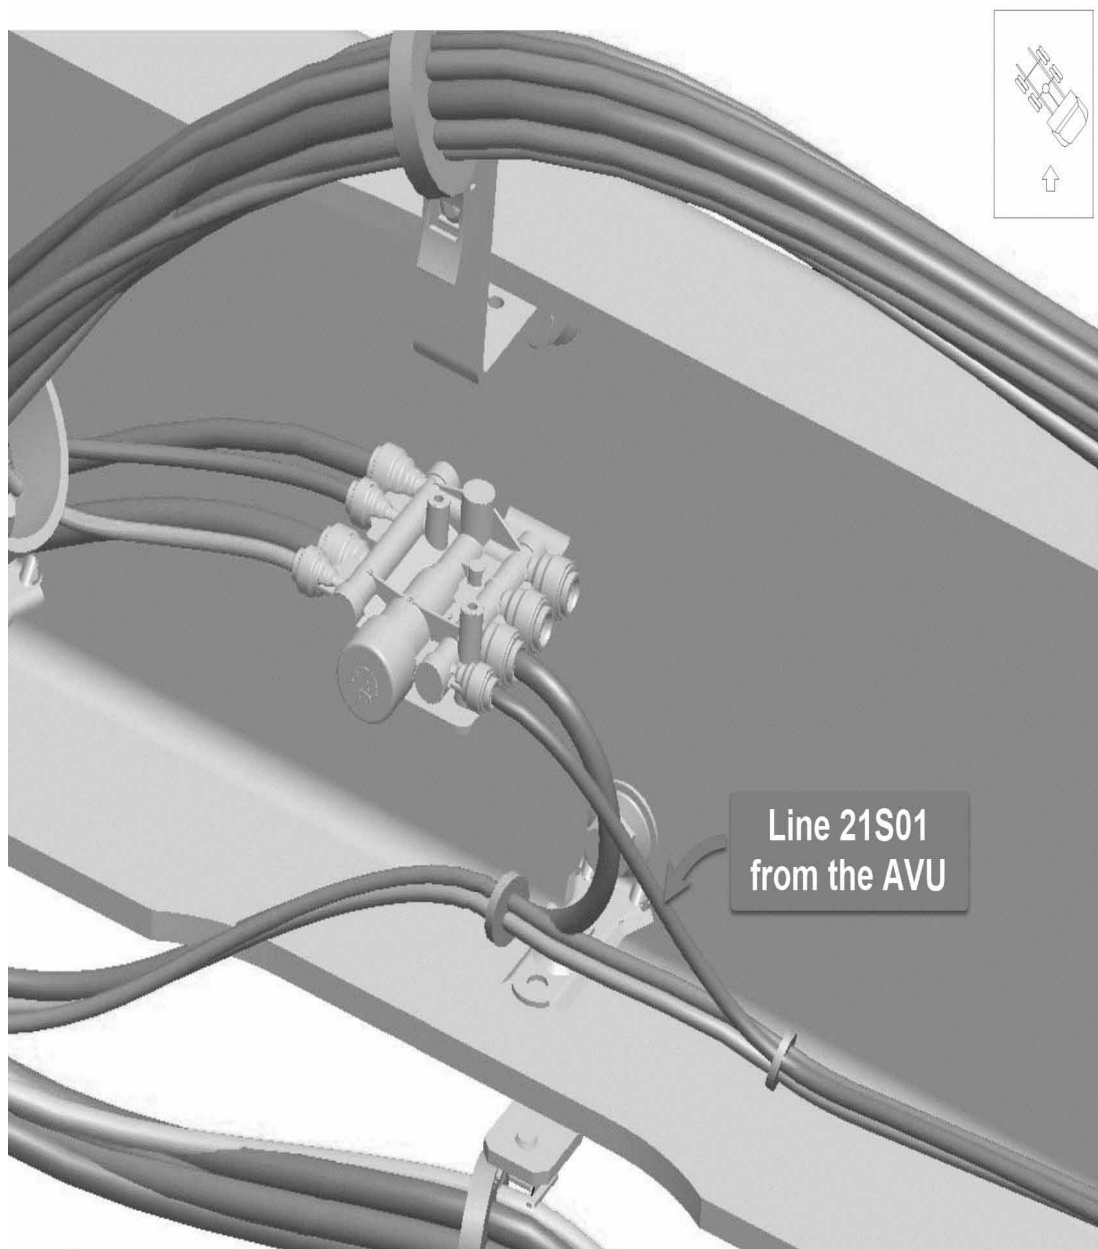
**1.2.** Disconnect the air line to the Pressure Protection Valve shown below:
