Technical product information

Topic	Transmission communication DTC's (Numerous)
Market area	Bentley: worldwide (2WBE)
Brand	Bentley
Transaction No.	2059068/1
Level	EH
Status	Approval
Release date

New Continental GT and New Continental GTC

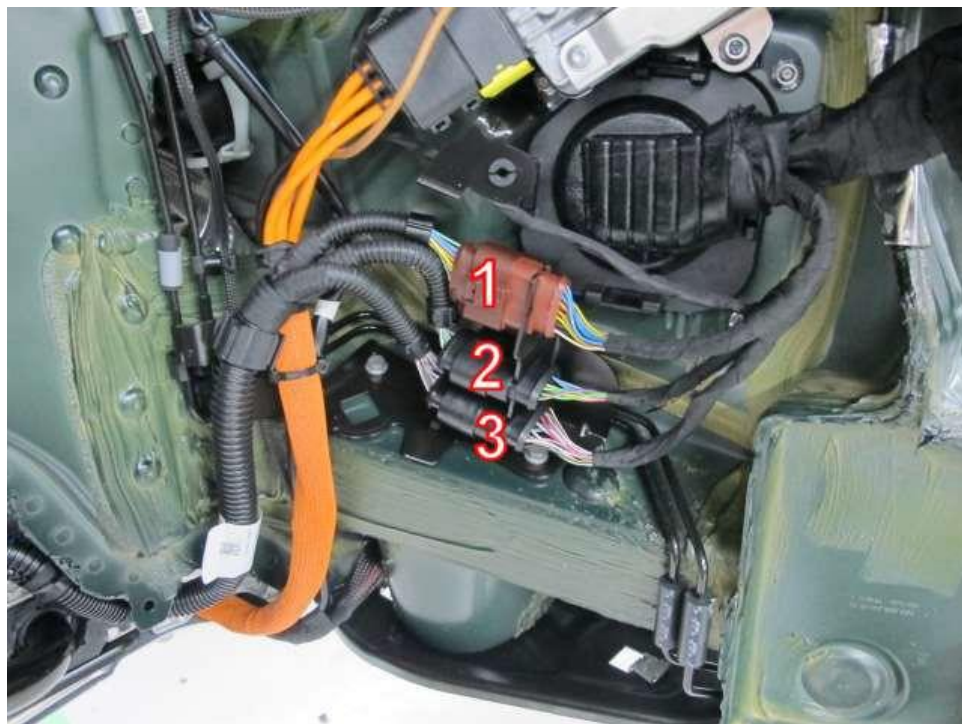
-
- Ensure the ignition is switched off for the duration of this procedure
- 1) Remove the left hand front wheel arch liner - Refer to Repair manual Rep.Gr 66
 - 2) Gain access and disconnect the transmission control module plug T58ag - Refer to Repair manual Rep.Gr 37
 - Referring to Figure 2 and the applicable current flow diagram - Disconnect the three connections
 - 3) Once disconnected carry out pin/terminal grab checks on all male and female connections (All three connections)

6) Should any issues be found on either end of the link harness, the link harness should be replaced.

Should any issues be found with the Mechatronic unit for dual clutch gearbox -J743- pin connections or the transmission control module pin connections - please raise a DISS query and await feedback before carrying out any further work

Should any issues be found with the male connections of any of the three connections (pins) these can be replaced as per normal wiring repair guidelines

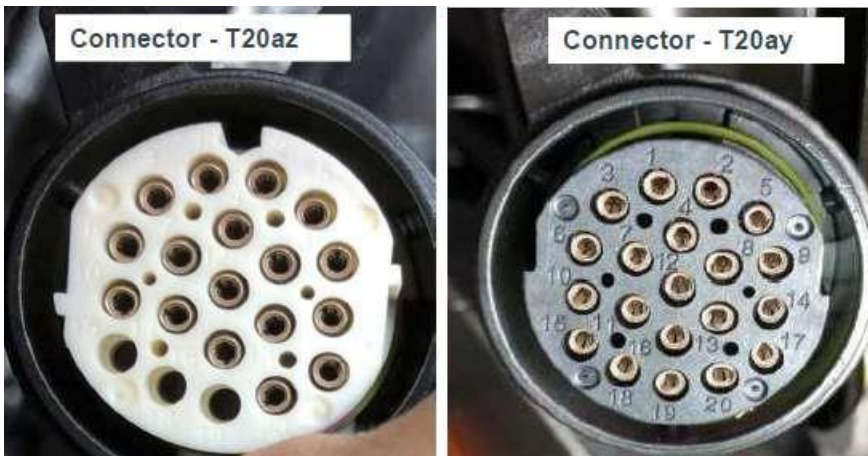
Figure 4

5) Disconnect the connections (Figure 4) from the Mechatronic unit for dual clutch gearbox -J743-

- Referring to the attached PDF document - Carry out resistance checks as detailed for the connectors shown in Figures 4 and 5
- Carry out pin/terminal grab checks on all connections (male and female)
