CAMPAIGN BULLETIN

Engine Control Module (ECM) Reprogram Dealer Inventory

Reference: PM945
Date: April 02, 2020

PM945 2020 KICKS ECM REPROGRAM

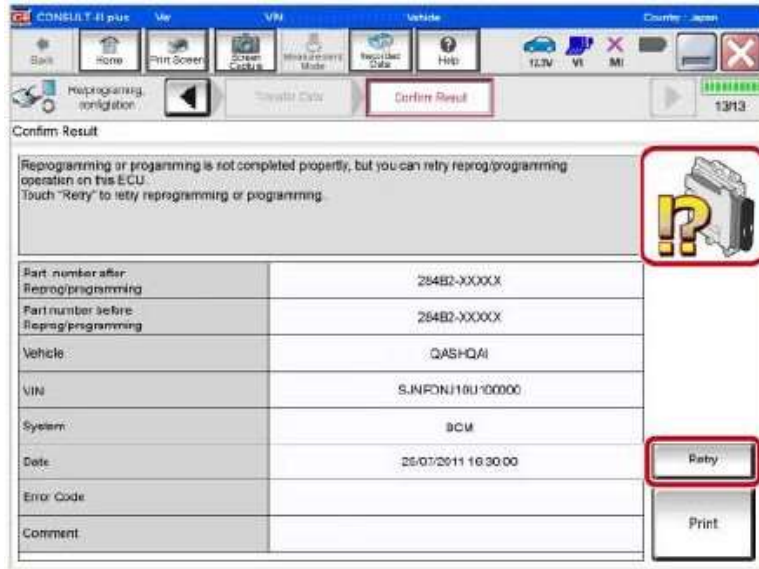
Figure 6

If reprogramming does **not** complete and the “!?” icon displays as shown in **Figure 6:**

- Check battery voltage (12.0–15.5 V)
- Ignition is ON, engine OFF
- External Bluetooth® devices are OFF
- All electrical loads are OFF
- **Select retry and follow the on screen instructions**
- “Retry” may not go through on first attempt and can be selected more than once

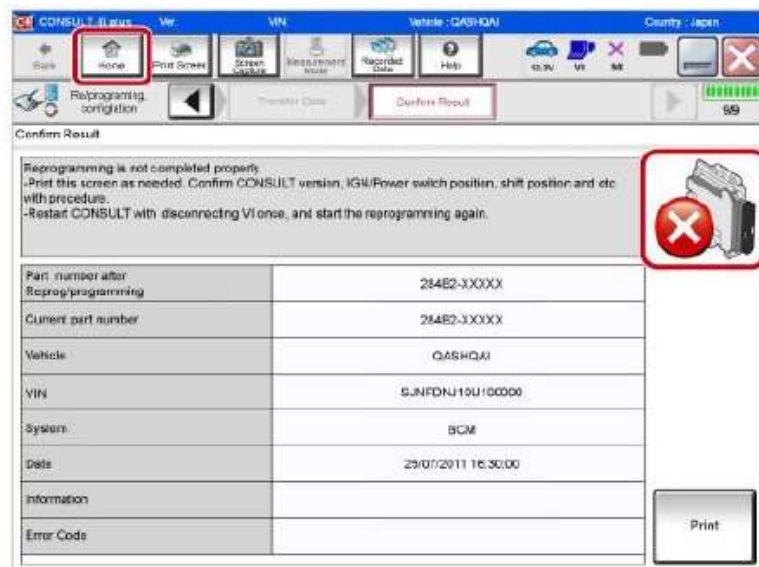
Figure 7

If reprogramming does **not** complete and the “X” icon displays as shown in **Figure 7:**

- Check battery voltage (12.0 – 15.5 V)
- CONSULT A/C adapter is plugged in
- Ignition is ON, engine OFF
- Transmission is in Park
- All C-III plus / VI cables are securely connected
- All C-III plus updates are installed
- **Select Home, and restart the reprogram procedure from the beginning**
