Service Bulletin

01-076

Model 520 HVAC Recirculation Door

4/8/2020

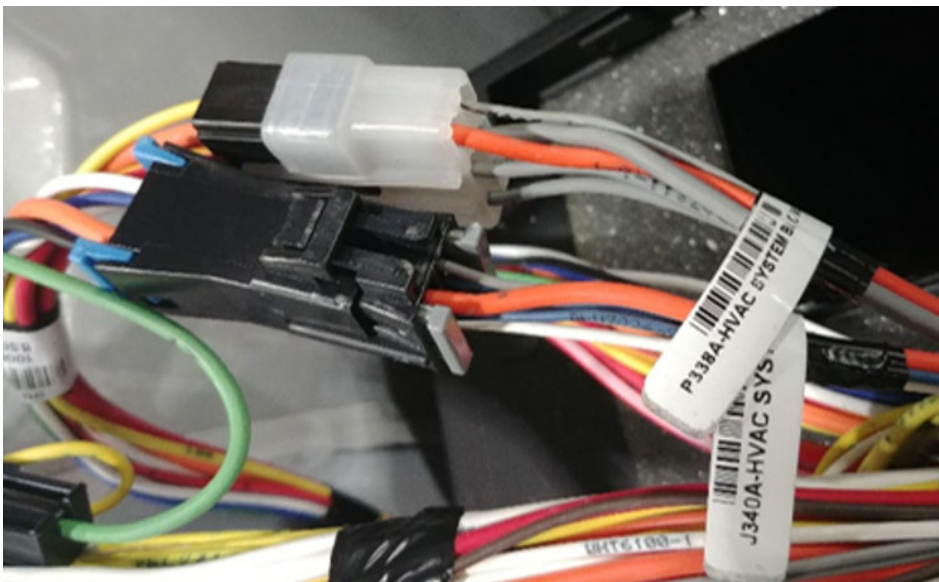
Peterbilt has determined that certain model 520 trucks manufactured between 6/20/2017 and 8/10/2018 with LH and RH Steer may have a Recirculation Air Blend Door that does not work properly. There is an additional circuit in the HVAC wiring that could cause the controls for recirculation mode and fresh air mode to operate opposite of their intended function.

7. The two connectors are on the passenger side at the back panel next to the fuse panel. The connections shown in Figure 7 are for Right Hand Steer.

1. Locate connectors J340A and P338A on the passenger side of the cab, above the HVAC main connection.
2. Remove wire GRA7223-3 from cavity "D" of connector J340A and seal the end of the wire with heat shrink tubing.
3. Remove wire GRA7223-1 from cavity "D" of connector P338A and seal the end of the wire with heat shrink tubing.
