# HYUNDAI

## Technical Service Bulletin

20-BD-011H

**SUBJECT:** TAILGATE OVERSLAM BUMPER ADJUSTMENT GUIDE

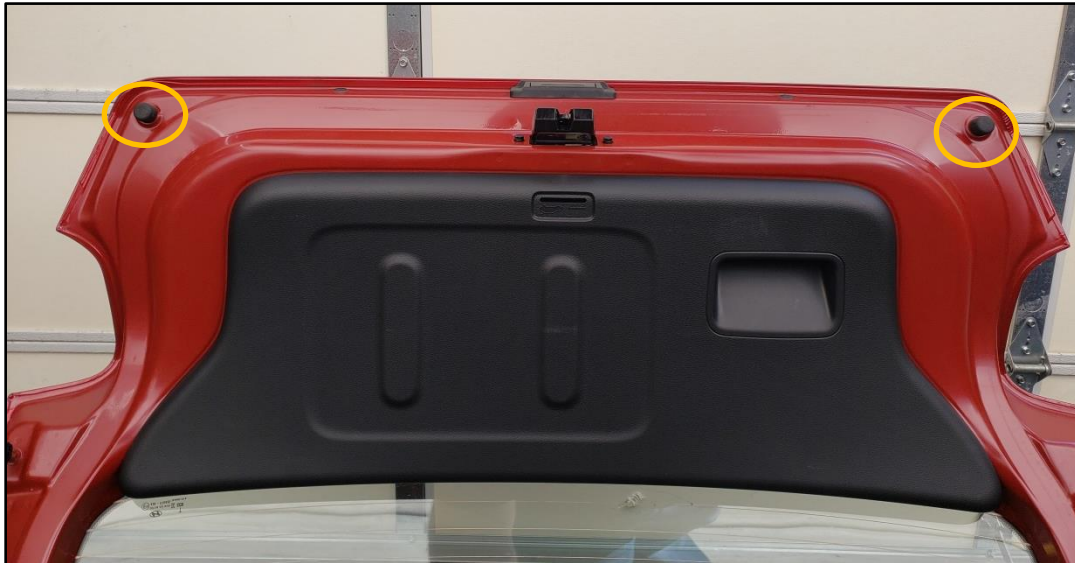
**Description:** Certain Venue (QX) vehicles may exhibit difficulty closing the tailgate. This bulletin describes the procedure to adjust the height of the tailgate overslam bumpers to repair this condition.

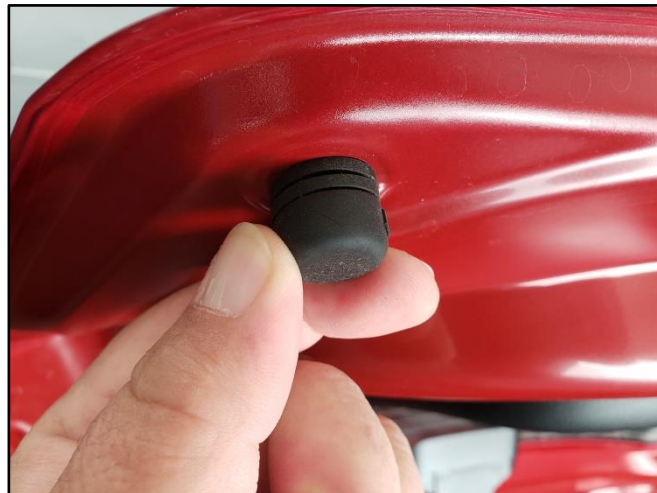
**If the overslam bumpers are too short, the tailgate can rattle when the vehicle is driven over bumps or rough surfaces.**

**If the overslam bumpers are too tall, the tailgate may not close properly.**

2. Twist an overslam bumper clockwise or counter-clockwise to decrease or increase its height.

**Both bumpers must be adjusted to the same height.**
