HYUNDAI Technical Service Bulletin

20-BD-013H

Sonata (DN8a)

WINDOW NOISE REPAIR

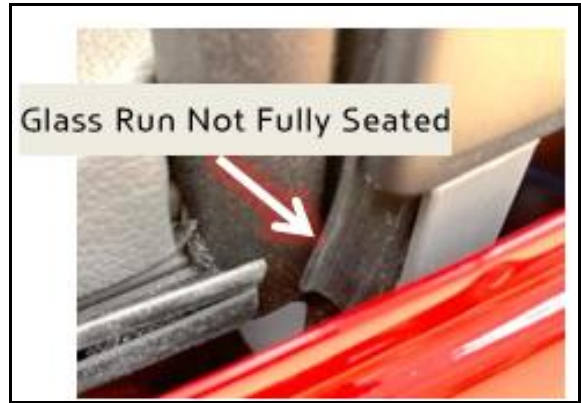
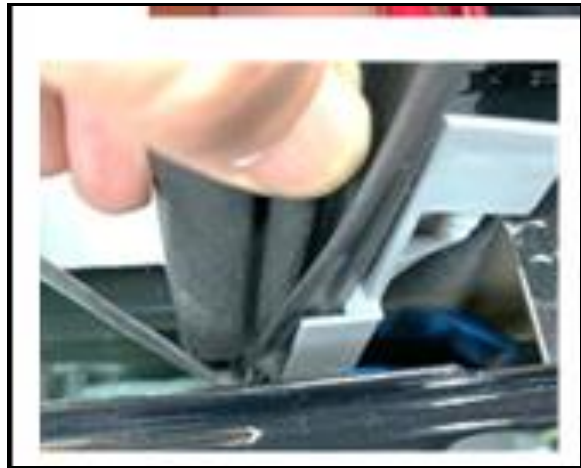
1. Inspect the glass run to determine if it is not seated.

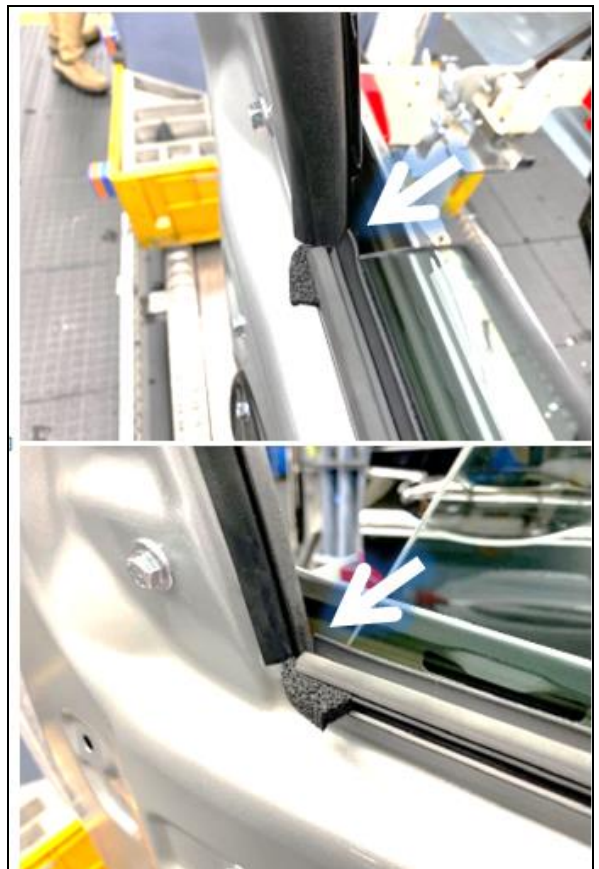
4. The belt molding should be aligned with the glass run weather strip.
