HYUNDAI Technical Service Bulletin	GROUP BODY ELECTRICAL	NUMBER 20-BE-007H
	DATE APRIL 2020	MODEL(S) GENESIS SEDAN (DH)
SUBJECT: TRUNK FLOOR WIRING HARNESS INSPECTION AND REPAIR

Description: On certain 2015-2016 Genesis (DH) vehicles, the trunk harness may be damaged due to tension against the trunk lid arm. This bulletin provides the procedure to inspect, repair when necessary, and reroute the wire harness.

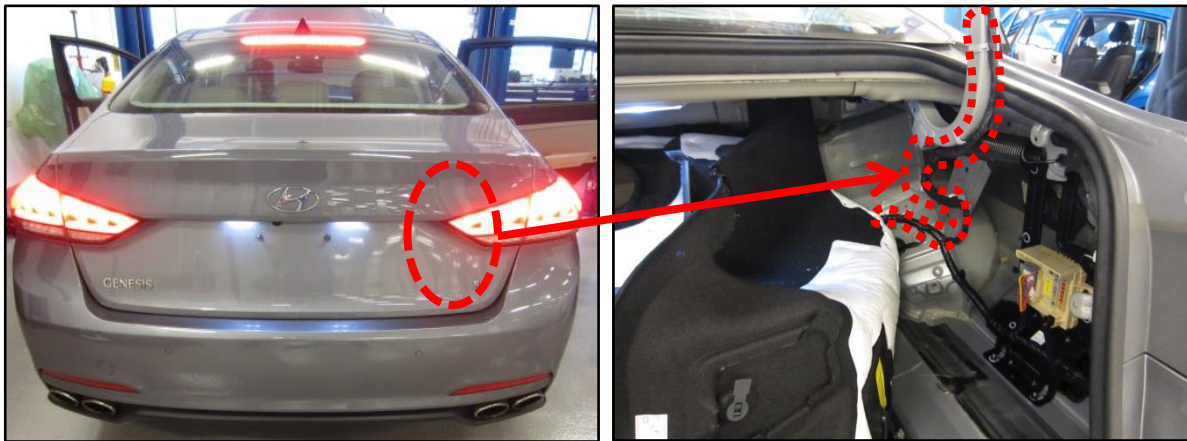
Possible conditions if the trunk harness is damaged:

1. Rear view camera inoperative.
2. Passenger side license plate light inoperative.
3. Passenger side inner brake light inoperative.
4. Passenger side inner reverse light inoperative.

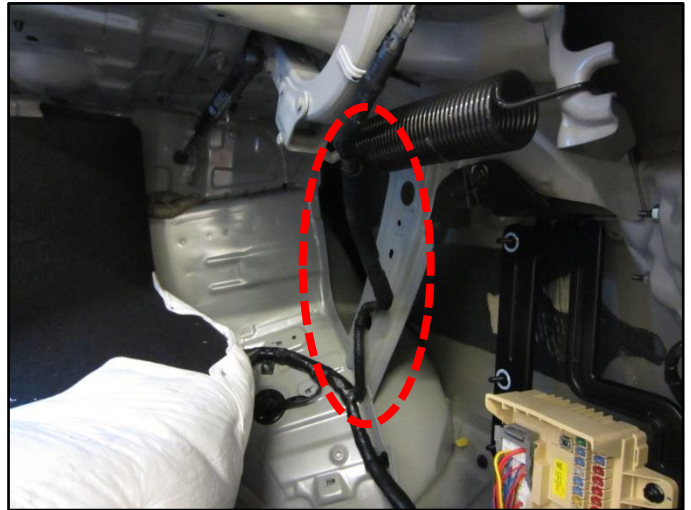
Location of the harness to be inspected.

13. Loosen the mounting screw (K).
Disengage the clip (L).
Remove the bracket (M).

Discard the removed bracket (M).

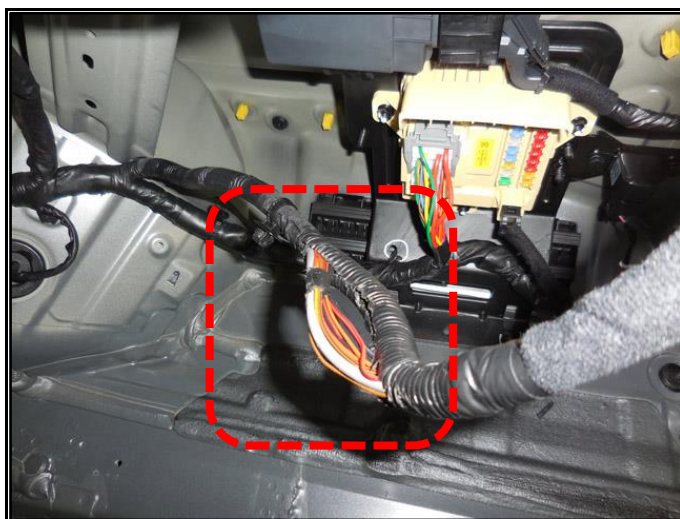
15. Inspect if there is any damaged or cut wire.
- If a wire is found damaged or cut, perform the procedure from below to repair it.
- If no wire is found damaged, then proceed to step 19.
