Service Update

A202299960 Shift Lever Cable Bolt Not Fully Fastened

Release Date: April 2020 Revision: 00

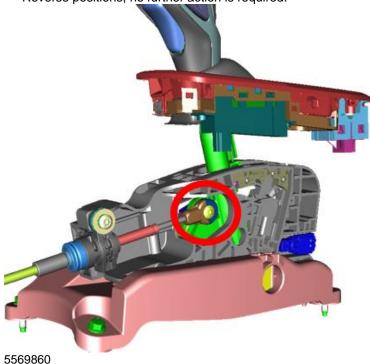
Condition	The gear shift lever may have a detent feel between Park and Reverse caused by the fastening bolt that
	is not fully seated and contacting the shifter housing.
Inspection	Dealers are to inspect the detent feel of the transmission range selector lever.

Caution: During part replacement, check to ensure the circled fastener is fully seated.

4. Hold the vehicle for repair until parts are available.
