# Customer Satisfaction Program

## N192264451 Premature Brake Wear Notification

**Release Date:** April 2020

**Revision:** 02

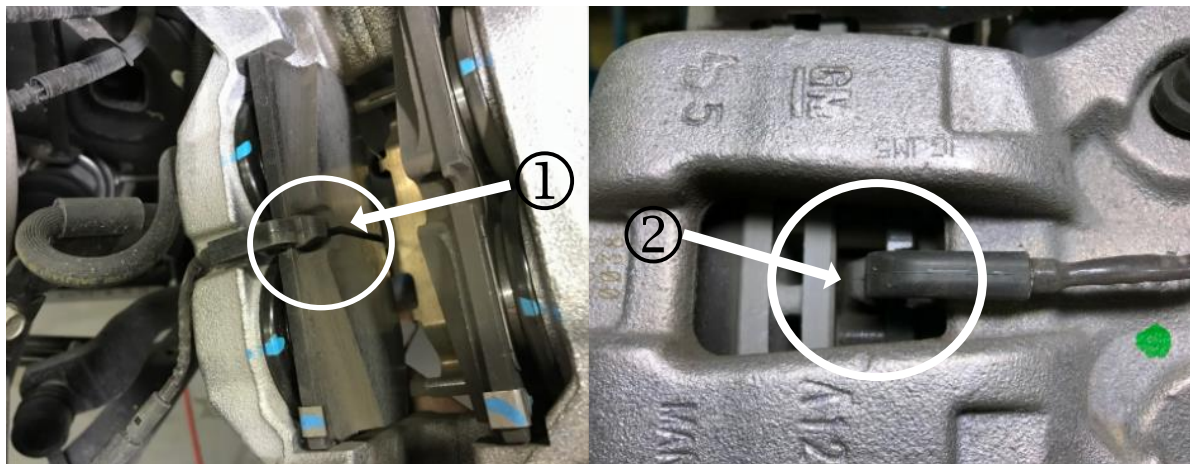
- Inspect the brake pad wear sensors on both the front (1) and rear (2) brake pads. Remove the front brake caliper to gain a clear view of the brake pad wear indicator for inspection as shown.

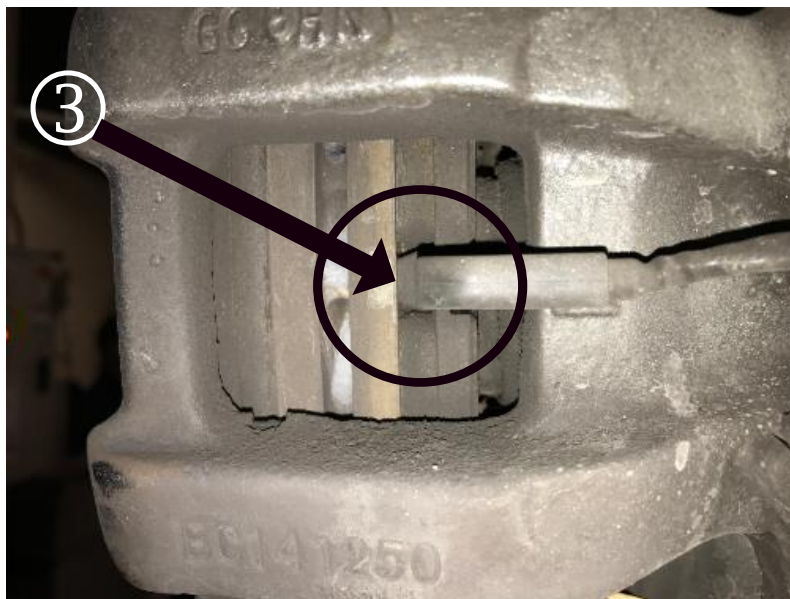
5445357

- If there is ANY wear on the brake pad wear sensors or if the sensors are contacting the rotor (3), replace the brake pads associated with the affected axle (front, rear or both) and continue to step 6. Example of a good brake pad wear sensor (1) and a worn brake pad sensor (2) shown above.
  - If there is NO wear on the brake pad wear sensors, continue to step 7.
6. Replace the front, rear or both disc brake pads depending on the axle set that shows sensor wear. Refer to *Front Disc Brake Pads Replacement* and *Rear Disc Brake Pads Replacement* in SI.
  7. Install the front caliper. Refer to *Front Brake Caliper Replacement* in SI for torque specification.
  8. Install the tire and wheel assemblies. Refer to *Tire and Wheel Removal and Installation* in SI.
  9. Lower the vehicle. Refer to *Lifting and Jacking the Vehicle* in SI.
