GLOBAL SAFETY FIELD INVESTIGATIONS
DCS5382
URGENT - DISTRIBUTE IMMEDIATELY

Subject: N202302840 - Service Update
Door Paint Chipping

Models: 2020 Chevrolet Corvette

N202302840 Door Paint Chipping

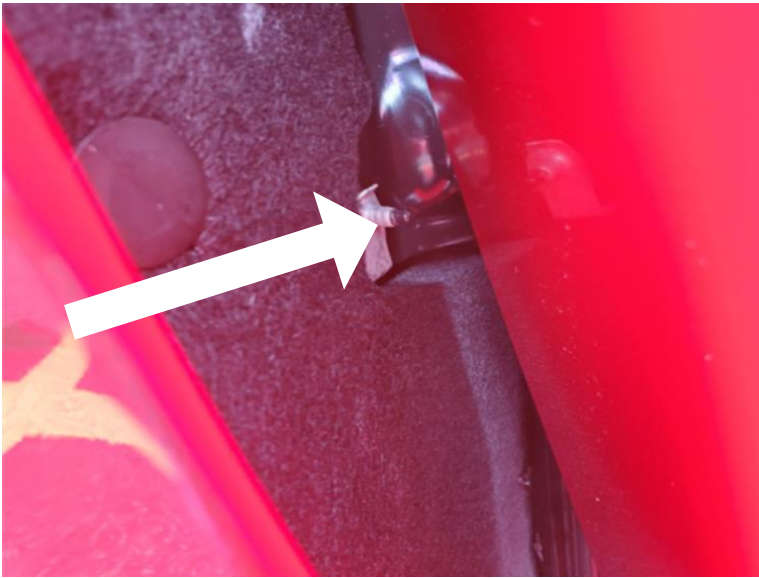
5584456

- If less than 1 full thread is showing, no further action is required.

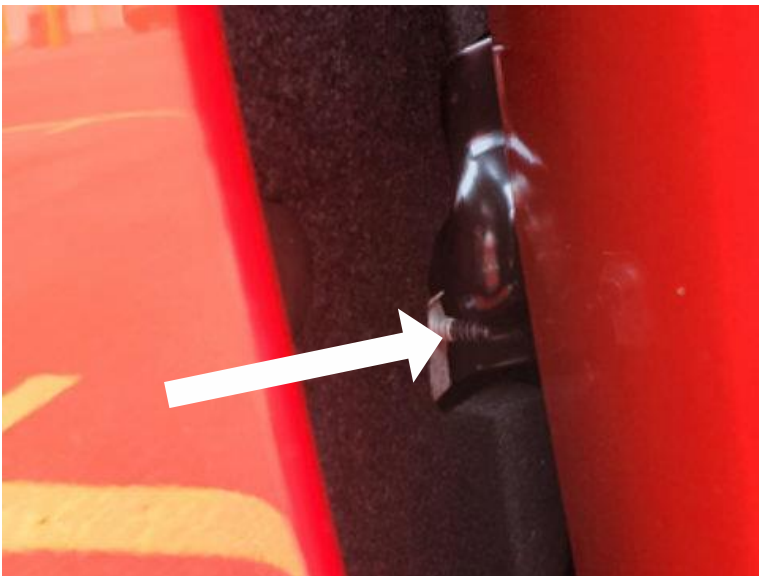
5584462

- If more than 2 threads are showing, proceed to step # 4.
4. Partially remove the wheelhouse liner to access the rear fender mounting fasteners. *Refer to Front Wheelhouse Liner Replacement in SI.*
