Bulletin No.: PIT5259F
Published date: 04/20/2020

PIT5259F Installation Tip - Door Striker Cover Installation During PDI

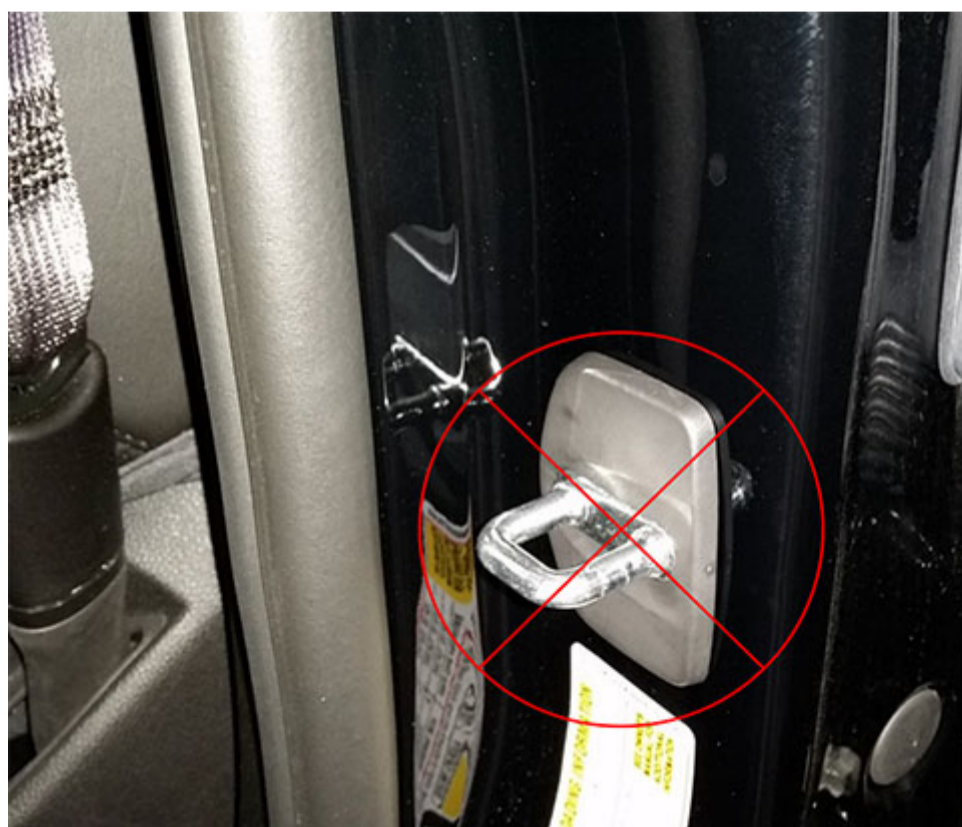
There have been reports of these covers being installed incorrectly / backwards, as shown below.

Make sure the rounded side of the cover is positioned towards the outboard side of the vehicle, as reflected below:
