Preliminary Information

PIC5650G Diagnostic Tip - Security Light on Intermittently / No Crank/No Start or Start Stall / Keyless Access Vehicles May Display No Remote/Fob Detected / Poor or No RKE Range / Service TPM

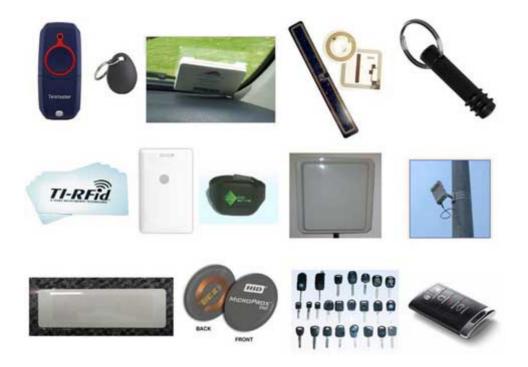
Listed below are a number of aftermarket devices that can cause RFI. In many cases, these types of devices will be attached to the customer's key ring and could be removed from the key ring or from inside the vehicle when the customer drops the vehicle off for service.

- Vehicle immobilizer keys from other vehicles
- Keyless access transmitters from other vehicles
- Interstate/bridge toll passes
- Gate/door passes to allow access to pools, driveways, entry doors, etc.
- Community/parking access cards
- Fuel station speed passes
- Building access swipe cards/ transponder devices

Before any in depth diagnosis is performed, question the customer or inspect the vehicle for any types of aftermarket equipment, like shown above, which could cause RFI. These items need to removed and/or disconnected from the vehicle.

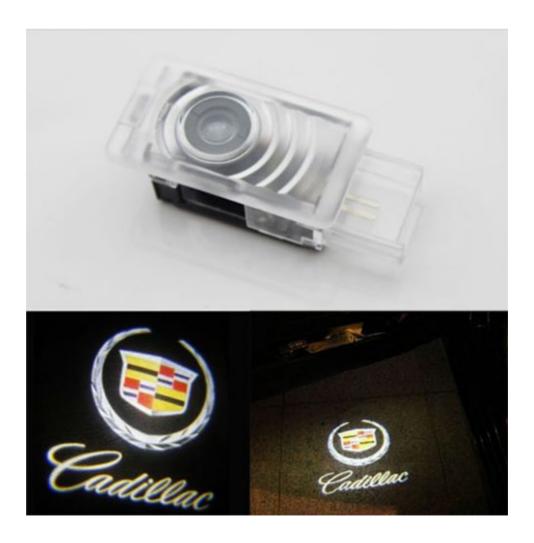
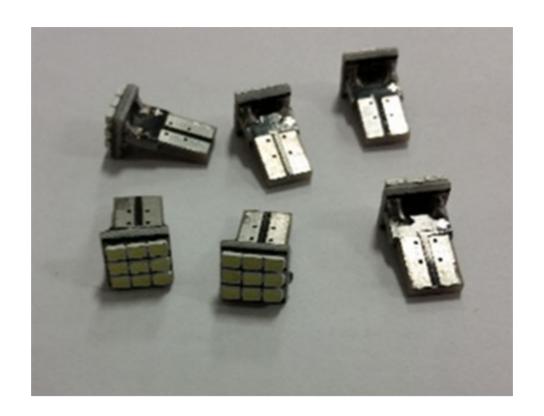
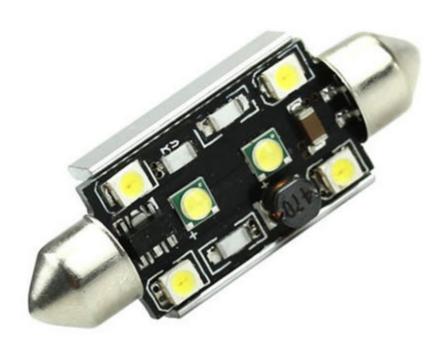
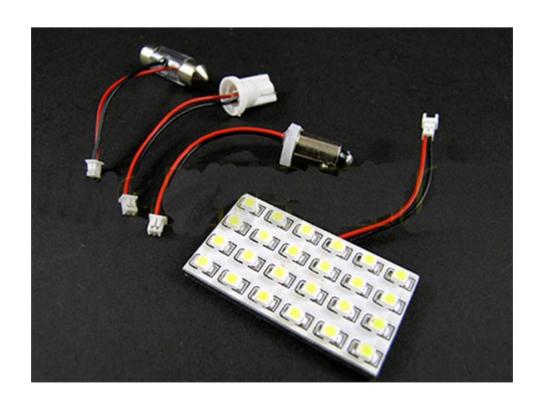
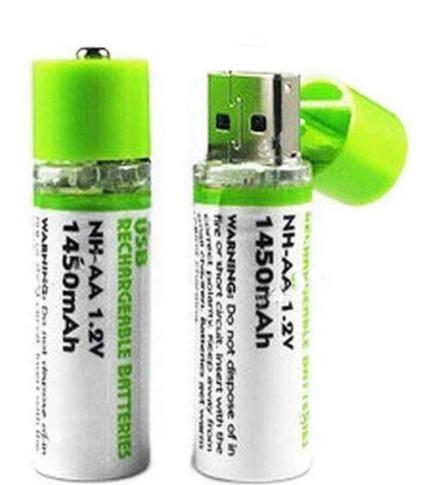
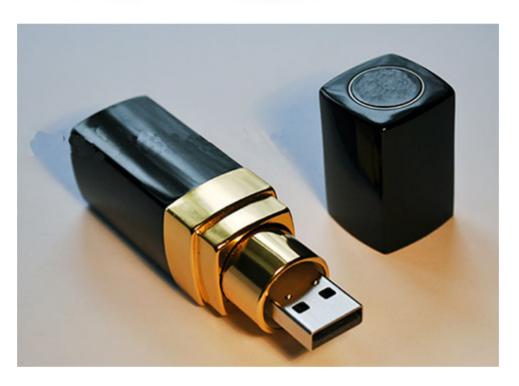
- Aftermarket LED dome, tail, turn, stop, strip, floor, door, Logo, head lights
 In many cases, when the LED lighting is turned on it can interfere with a RF signal. Example, RKE inoperativater the first fob button press. When the RKE fob button is pressed the dome lights may turn on, which if equippedith an aftermarket LED dome light, it can interfere with any additional fob button presses.
- Certain cell phone chargers
- USB power banks
- USB flash lights
- Fans (12 volt or 110 volt)
- Any type of USB, 12 volt or 110 volt chargers
