MIL ON With DTC P211904 - 2GR-FKS (6MT)

Category Vehicle Interior

Section Meter/Gauge/Display Market USA

TOYOTA T-SB-0043-20 April 21, 2020 Page 2 of 5

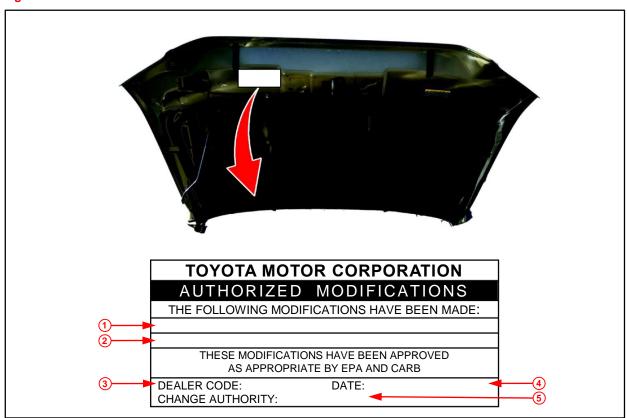
Figure 1. Location of Authorized Modifications Label on 2016 - 2017 Tacoma

2. Use Techstream to confirm if the ECM (PCM) calibration has been updated and check for the Authorized Modifications Label affixed to the vehicle in the location shown below.

- 4. Prepare and install the Authorized Modifications Label.
 - A. Using a permanent marker, enter the following information on the label:
 - ECM (PCM) part number [Refer to the Parts Information section for the NEW PART NUMBER]
 - Calibration ID(s) [Refer to the **Calibration Information** section for the **NEW CALIBRATION ID**]
 - Dealer Code
 - Repair Date
 - Change Authority [This bulletin number]
 - B. Install the Authorized Modifications Label onto the vehicle at the location shown in Figure 1. The Authorized Modifications Label is available through the MDC, P/N 00451-00001-LBL.
- 5. Test-drive the vehicle to confirm proper operation.
