TESLA	Tesla, Inc. Service Bulletin		Reroute Main Front Body Harness				
SB-20-17-004 April 23, 2020		R1					
Classification			Section/Group	Mobile Service			
Campaign Bulletin			17 - Electrical	Can Perform (where permitted)			
Model Yea	ar Model		Country/Region	Version			
2017 - 2019	Model X		All	All			
The model(s) and model year(s) listed are a general approximation of the affected VIN list. Refer to the VIN/Bulletin Tracker or Customer/Vehicle profile to determine applicability of this bulletin for a particular vehicle.

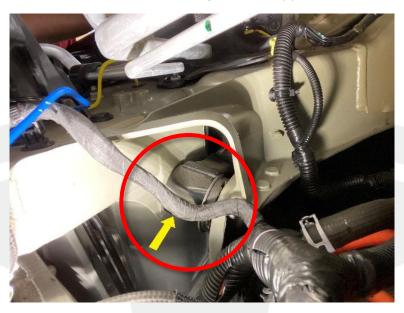
Figure 1

On certain Model X vehicles, the main front body harness might contact the RH front upper control arm.

- 3. Inspect the fuse box harness branch at the main front body harness near the RH front upper control arm for damage (Figure 1):
 - If there is no sign of the harness contacting the RH front upper control arm, or if the harness is contacting the RH front upper control arm but the insulation of the wires is still intact, continue to the next step.
 - If any of the harness wires are damaged or exposed, repair the harness. Refer to <u>SI-17-17-002</u>, "Electrical Harness Repair" for further instructions on how to repair the wire(s), and then continue to the next step.
