Mercedes-Benz

Campaign No. 2020030022, April 2020

SUBJECT: **Model 907 (Sprinter), Model Year 2019**
Steering Column Cover

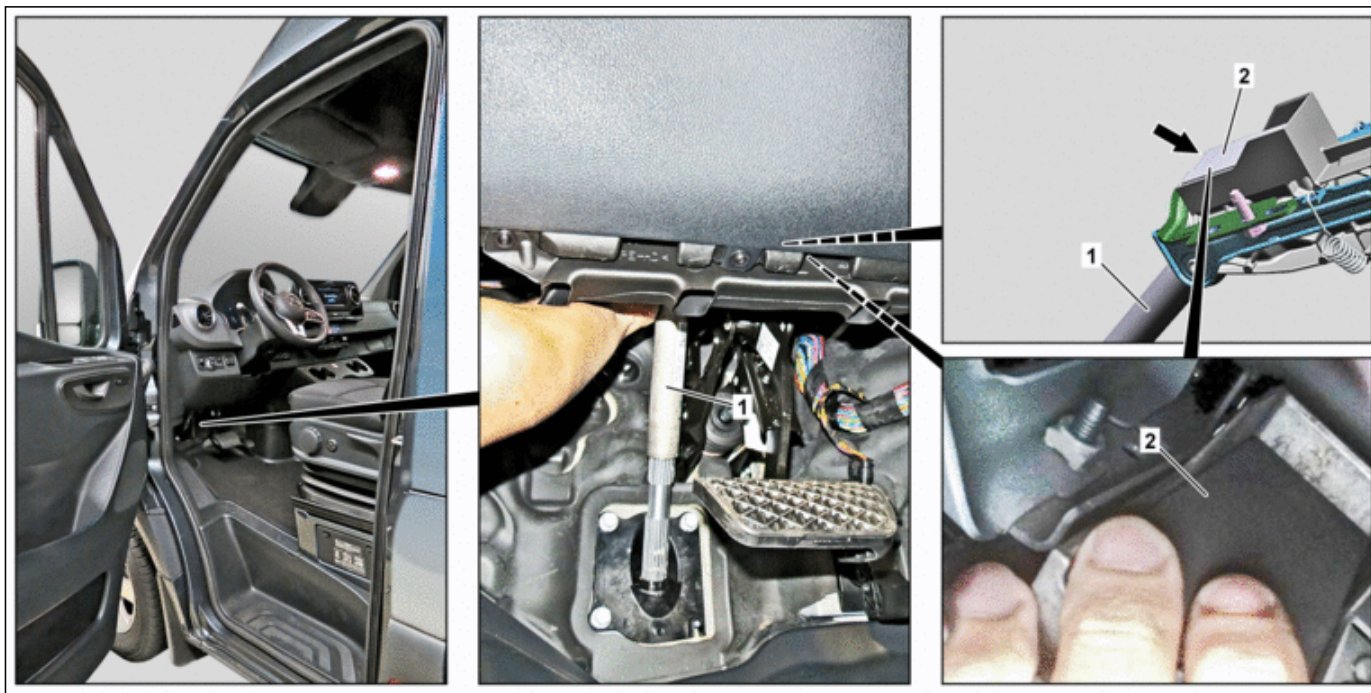
D46.10-A004-79

1 Steering column

2 Cover

☐	Check		
1	Check, whether the vehicle is affected by the measure.	<p>i</p> <p>Only the entry in the "Extended VEGA Application" (EVA) system in the "Current" tab is decisive for authorized Mercedes-Benz service partners. An additional test of the affected vehicles in the workshop information system (WIS) or vehicle list is thereby not necessary.</p>	
2	Check whether the cover (2) is installed.	<p>i</p> <p>To do so, grasp under the instrument panel by hand from the driver footwell and determine whether the cover (2) is installed. The foam-type cover (2) is soft and can be easily deformed with fingers (arrow).</p> <p>If the cover (2) is installed, ↓ end the measure.</p> <p>If the cover (2) is not installed, ↓ Replace the steering column.</p>	AR46.10-D-0400TS
