Technical Service Bulletin

64 Creaking noises from the front or rear windshield area

64 20 73 2046397/4 May 5, 2020. Supersedes Technical Service Bulletin Group 64 number 17-46 dated December 4, 2017 for reasons listed below.

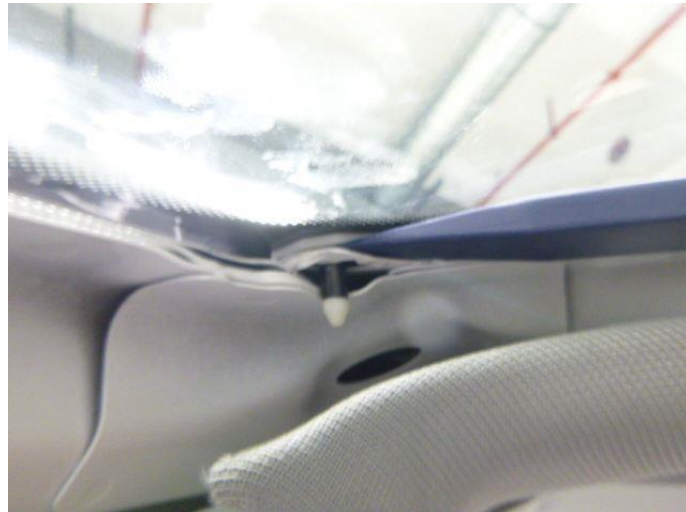
- Creaking noises in the front windshield area on the upper A-pillar or the upper corners of the rear windshield. The noise can occur on the left or right sides of the front and rear windshield.

The guide pins on the upper end of the windscreen and rear window, which are needed in production for positioning, make noises when scraping on the body.

Figure 1. Increase the distance between the plastic pin and metal lug.

1. If the noise occurs on the windshield in the A-pillar area, remove the sun visor and the A-pillar trim according to the repair manual. Once you can see the plastic pin and the metal lug which is in the plastic pin as shown in the illustration. Increase the distance between the plastic pin and the metal lug with a plastic wedge by bending down the metal lug by 1-2mm (Figure 1).

2. After the repair, check whether the noise is still there by pressing down on the windshield near the guide pin. If the noise is still there, you can increase the distance between the plastic pin and metal lug a little more.
