## STAR ONLINE PUBLICATION

**Case Number:** S2023000019

**Symptom/Vehicle Issue:** Noise From Headliner Roof Area

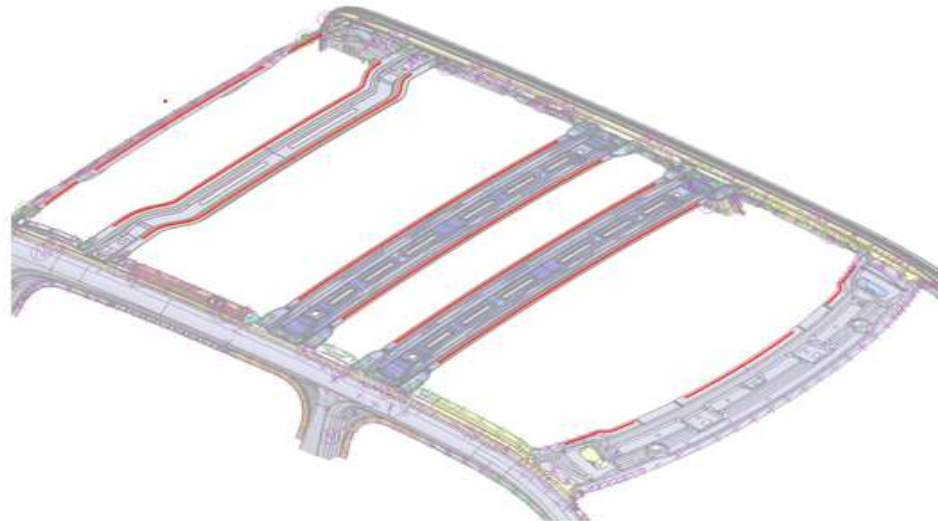
**Discussion:** A rattle or buzz noise complaint from above the drivers head could be a separated roof anti flutter foam joint. Once the complaint is verified, proceed to the repair steps below.

1. Removal of headliner. Refer to Service Information in TechCONNECT. 23 - Body / Interior / HEADLINER / Removal and Installation.
2. Inspect the roof bow foam for separation. See red line locations below.

3. Inspect for loose or missing foam. Remove any loose pieces. Remove foam from any areas that are not bonded to both surfaces.
4. Use MoPar Windshield Urethane 04864015AD or equivalent to fill the entire void. Ensure gap is filled between roof bow and roof panel. Use drop cloths and or tape to prevent urethane from contacting other interior areas. Follow curing instructions on the urethane kit.
5. Reinstall headliner and interior. See 23 - Body / Interior / HEADLINER / Removal and Installation.
