NUMBER: 08-033-20

Intermittent No Crank No Start

2020 (DT) RAM 1500 Pickup

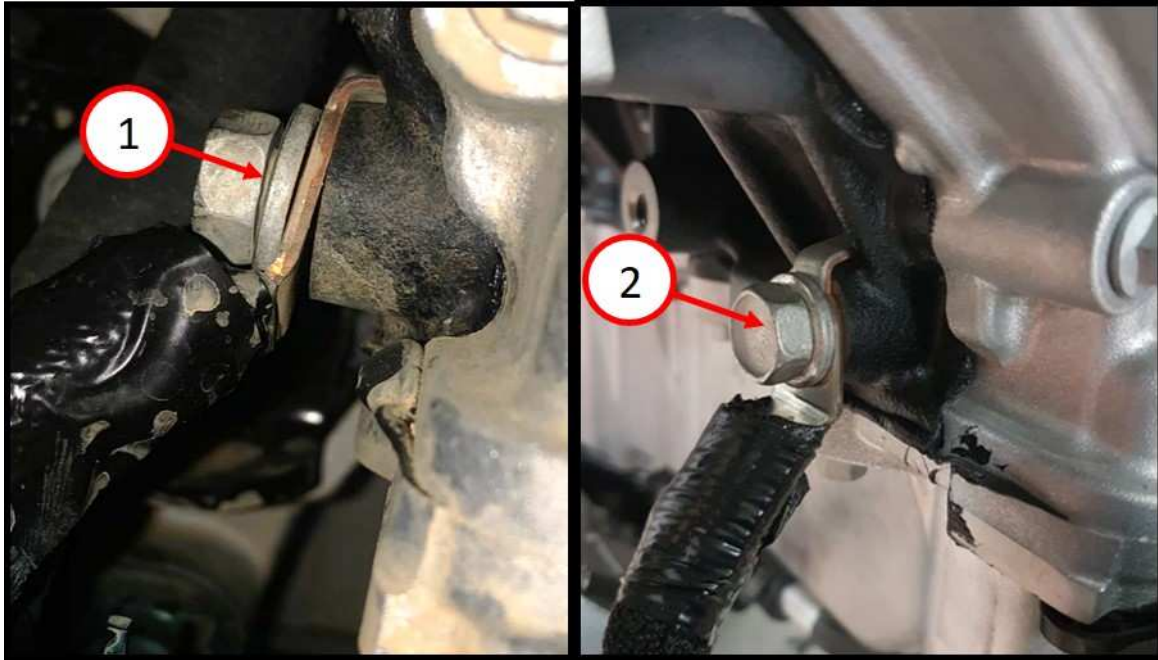
Fig. 1

1. Inspect the bolt securing the ground terminal from the battery negative to the engine block (Ground G0A). Do this by wiggling the cable to see if it is loose. (Fig. 1) .

Ground Terminal From The Battery Negative To The Engine Block (Ground G0A)

1 - Incorrect Bolt (42mm)

2 - Correct Bolt (30mm)

2. Is the ground terminal loose?

1. Disconnect the battery. Refer to the detailed service procedures available in DealerCONNECT/ Service Library under: Service Info>08 - Electrical / 8F - Engine Systems / Battery System / Standard Procedure> Battery Disconnect and Connect.
2. Remove and discard the bolt securing the ground terminal from the battery negative to the engine block.

3. Install the new bolt securing the ground terminal from the battery negative cable to the engine block. Tighten the bolt to 30 N·m (22 ft lbs.).
4. Reconnect the battery. Refer to the detailed service procedures available in DealerCONNECT/ Service Library under: Service Info>08 - Electrical / 8F - Engine Systems / Battery System / Standard Procedure> Battery Disconnect and Connect.
