NUMBER: 08-041-20

Flash: Electric Power Steering (EPS) Module Updates

2019 (BV) Jeep Renegade

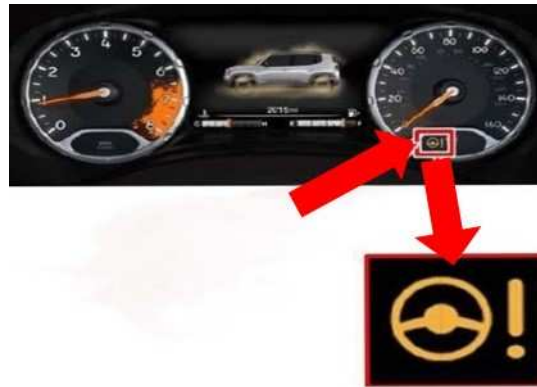
Fig. 1
IPC Warning Lamp

- Power steering system warning lamp is illuminated on the Instrument Panel Cluster (IPC) (Fig. 1) .

1. Reprogram the EPS module with the latest software. Detailed instructions for flashing control modules using the wiTECH Diagnostic Application are available by selecting the application's "HELP" tab.
2. Clear all DTCs that may have been set in any module due to reprogramming. The wiTECH application will automatically present all DTCs after the flash and allow them to be cleared.
