**NUMBER:** 08-024-20 REV. A

Connected Services Including Mobile App Services - Inoperative

2019 - 2020 (MP) Jeep Compass

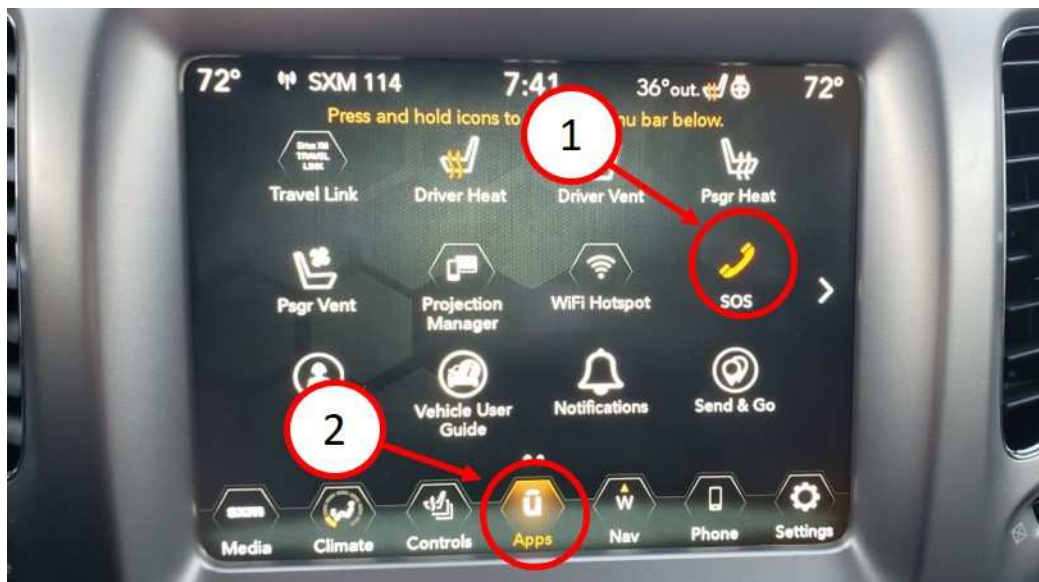
Fig. 1  
SOS App

- 1 - SOS Icon  
2 - Apps Icon

1. Using wiTECH, "Restore Vehicle Configuration". This routine is available under the "Guided Diagnostics" tab found on the home, "Vehicle View", page of wiTECH.
2. Perform a "Proxi Configuration Alignment" and follow all prompts:
  - a. Cycle the ignition OFF, unplug wiTECH pod and close the doors to let all modules go to sleep.
  - b. Reconnect wiTECH.
  - c. Cycle the ignition "ON" again.
3. Using wiTECH, perform a Radio/ETM hard reset, return to "Guided Diagnostics". Select "Reset ECU", then select "ETM", then follow screen prompts. After the ETM reset completes, the Connected Services apps should now appear.
4. Clear any DTC's which may have been set during this repair procedure.
5. Confirm the repair by going into the "Apps" section of the radio, then confirm the "SOS" icon is present on one of the pages (Fig. 1) .
