Technical Journal

Roller blind, rattle noise when opening

| REF NO: TJ 33183.3.0 | ISSUING DEPARTMENT: Technical Service | CAR MARKET: United States and Canada | |

TJ Instruction VCC-519080-1

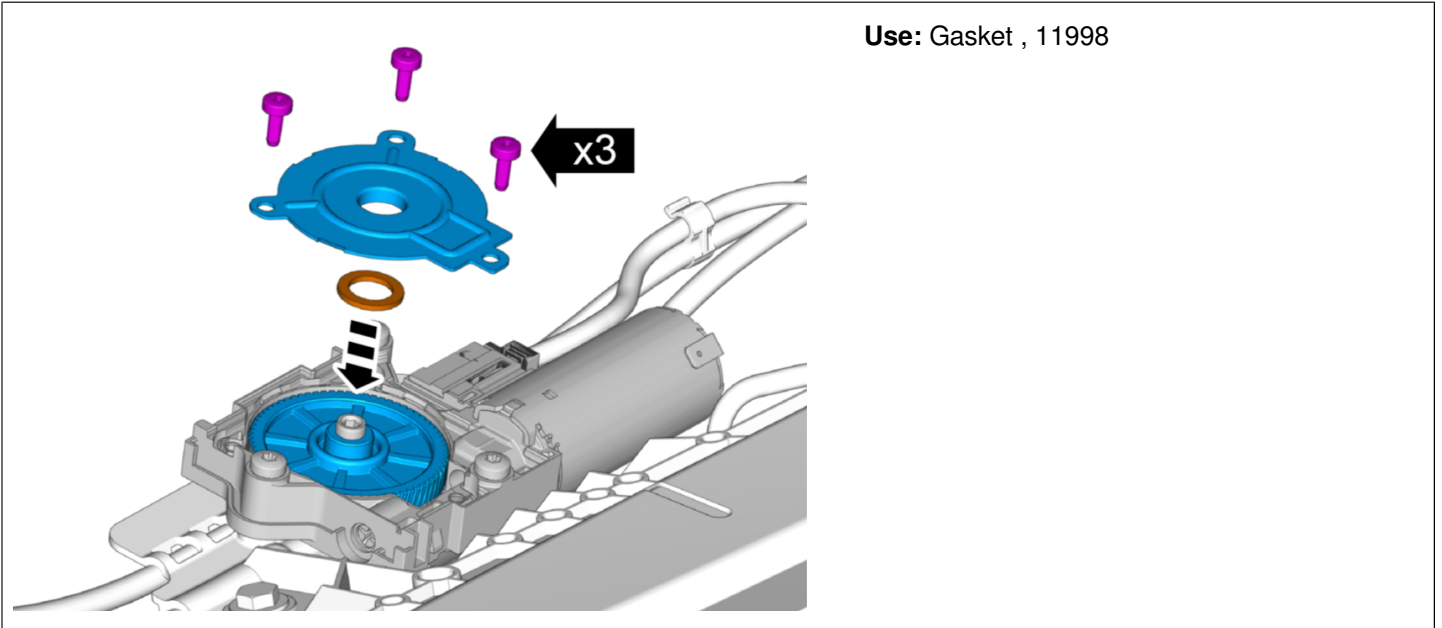
If a vehicle with panorama roof shows symptom of a rattling noise from roller blind when opening, follow the description under Service.

Use: Gasket , 11998

To install, reverse the removal procedure.
