SIB 01 05 20

N47T/N57T EGR COOLER: LTD WTY EXTENSION TO 10 YEARS
WITHOUT MILEAGE LIMIT

N47T Engine EGR Cooler Diagnosis and Determining the Condition of the Intake System

N57T Engine EGR Cooler Diagnosis and Determining the Condition of the Intake System

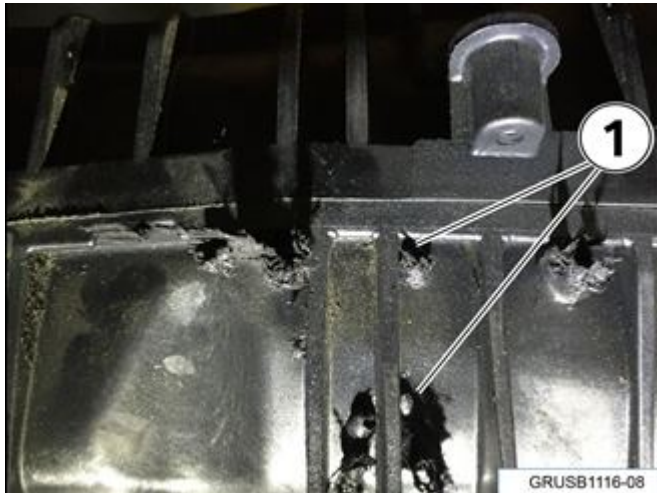
1. Remove the engine cover and inspect the intake manifold and venturi pipe to the throttle for holes or cracks.

Are there visible signs, on the intake manifold and venturi pipe, of overheating, similar to the illustration (1)?

- YES – go to step 5.
- NO – continue with step 2.

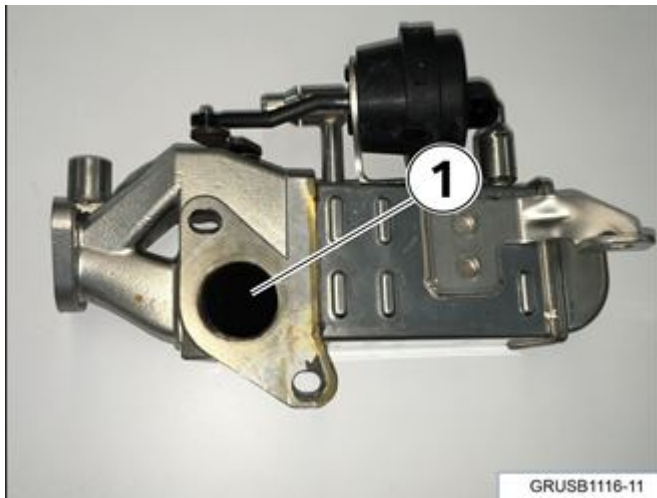
12. Inspect the cooler by-pass flap (1).

Is the flap intact?

YES- Check the production date of the cooler (1). If the production date is before 15.02.20 (**YY.MM.DD or February 20, 2015**) replace the cooler. If the production date is newer – reinstall the cooler.

NO (flap missing or damaged) – Replace the cooler and continue to step 13.
