SIB 13 03 20

## DELIVERY STOP: REPLACE HIGH-PRESSURE PUMP

G01 (X3 Sports Activity Vehicle)	G05 (X5 SAV)	G12 (7 Series Sedan)	G20 (3 Series Sedan)
G30 (5 Series Sedan)

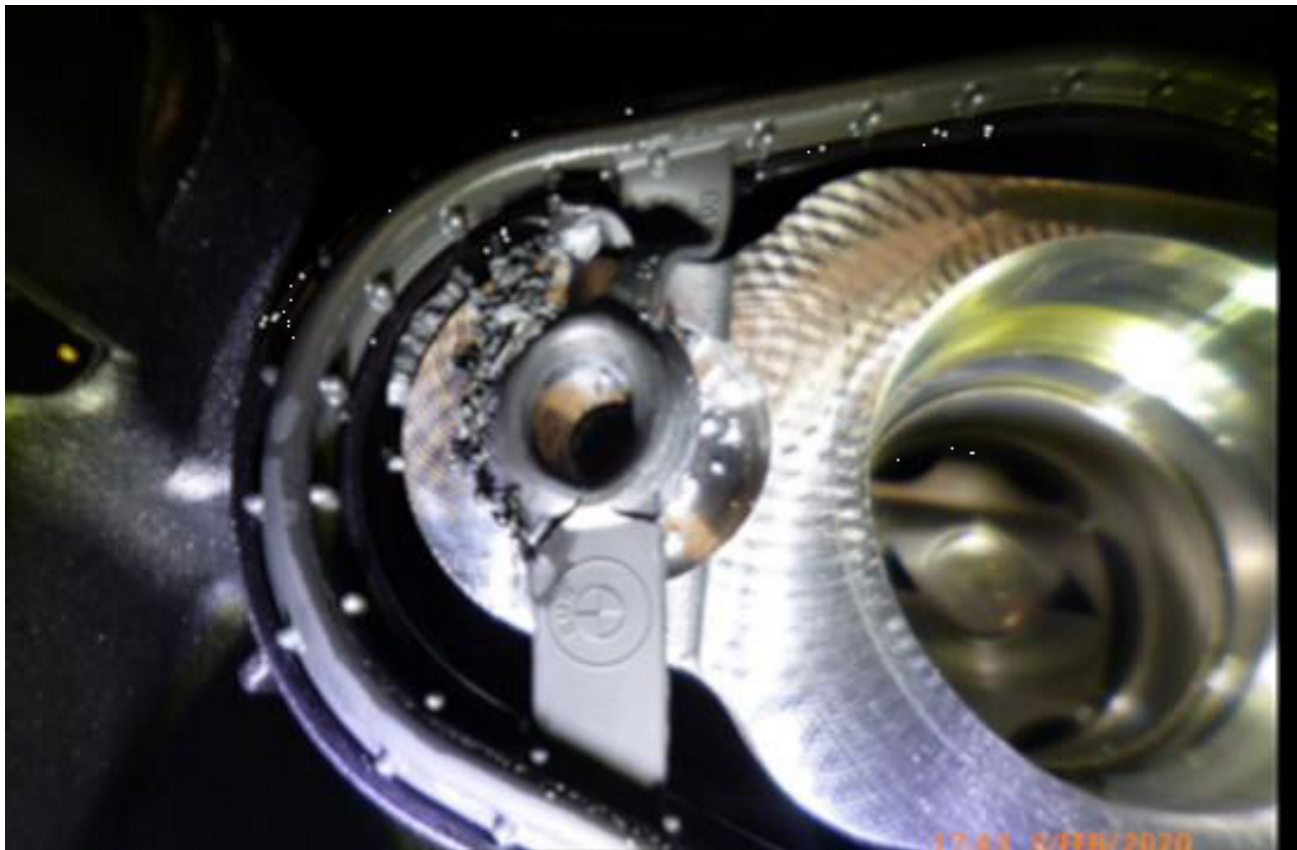
1. Remove the high-pressure pump as per Repair Instruction 13 51 017 "Removing and installing high pressure pump".
2. For quality control purposes, capture a photo of the high-pressure pump gasket area as seen in the example below.

3. Email the photo with the VIN in the subject line to [TAHDPDichtung@list.bmw.com](mailto:TAHDPDichtung@list.bmw.com). Do not wait for a response.

4. Install the new high-pressure pump as per Repair Instruction 13 51 017 "Removing and installing high pressure pump".
