SIB 51 12 20

FIBERS PROTRUDING FROM CENTER SPEAKER COVER

E-Series	Model Description
F95	X5 M Sports Activity Vehicle
F96	X6 M Sports Activity Coupe
G05	X5 Sports Activity Vehicle
G06	X6 Sports Activity Coupe
G07	X7 Sports Activity Vehicle

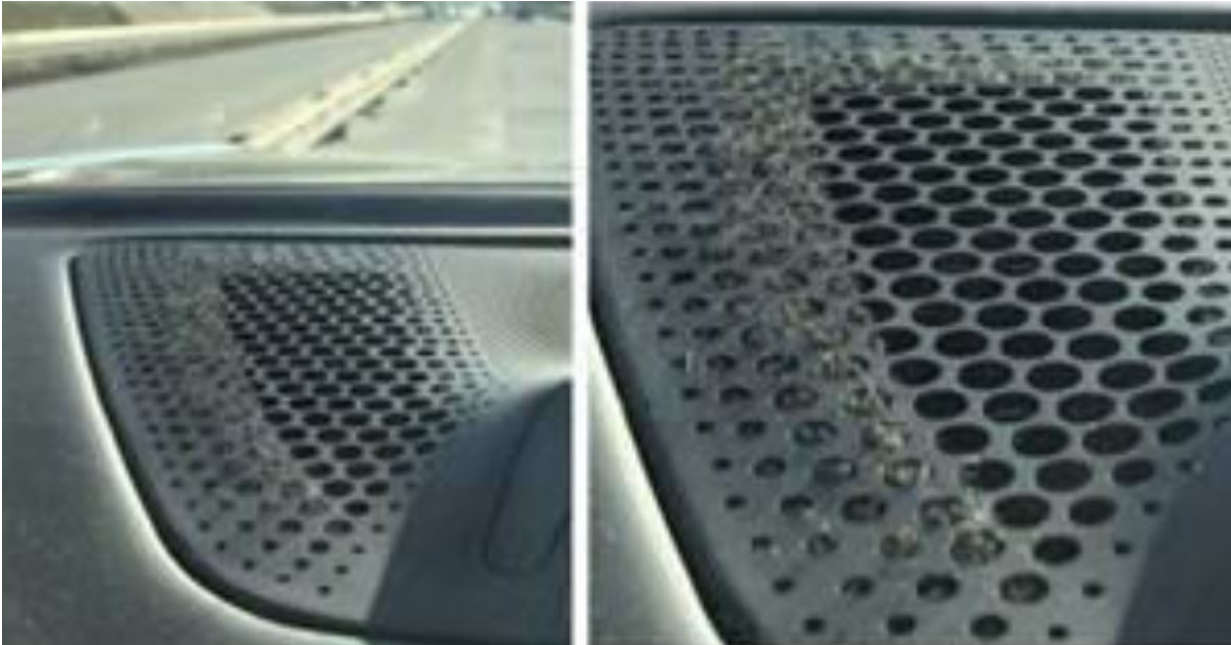
Fibers are protruding from beneath the center dashboard speaker cover.

Insulation material underneath the speaker may become loose.

The situation may become even more noticeable on those vehicles where the dashboard area is cleaned using a vacuum cleaner.

Replace center speaker cover.

**Ensure the dashboard is not being cleaned using a vacuum cleaner going forward.**

Replace the center speaker cover. Repair instructions are included as part of REP 65 13 060 "Removing and installing/replacing the loudspeaker (Mid-Range speaker) (in dashboard trim).
