SIB 51 14 20

RATTLE NOISE FROM DASHBOARD CENTER SPEAKER COVER

E-Series	Model Description
G20	3 Series Sedan

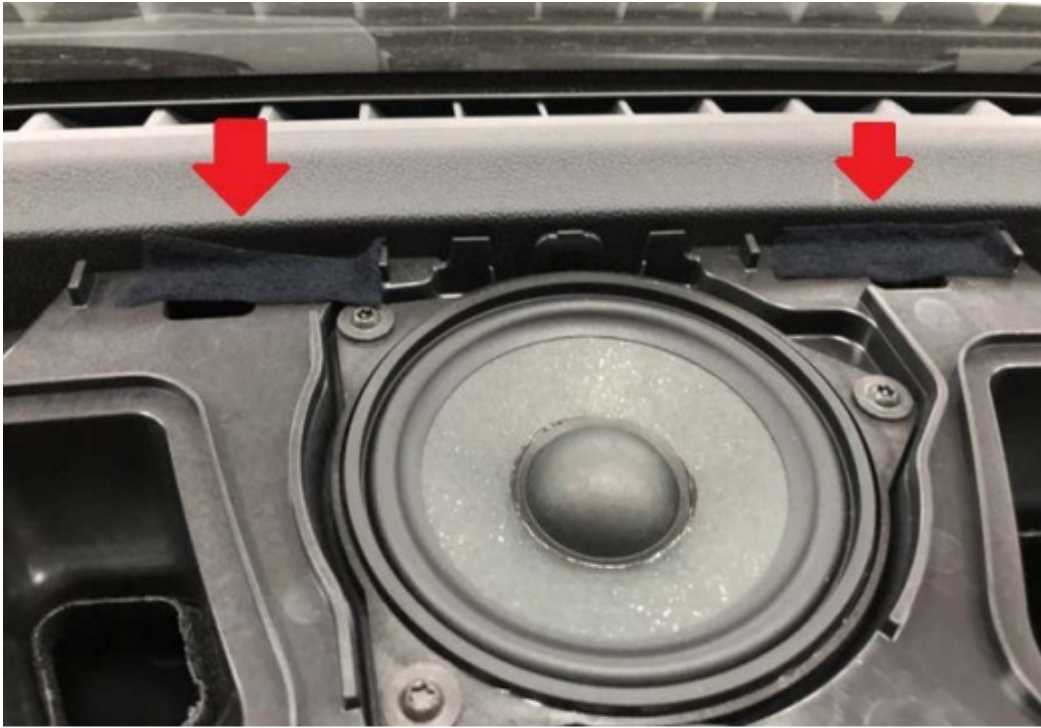
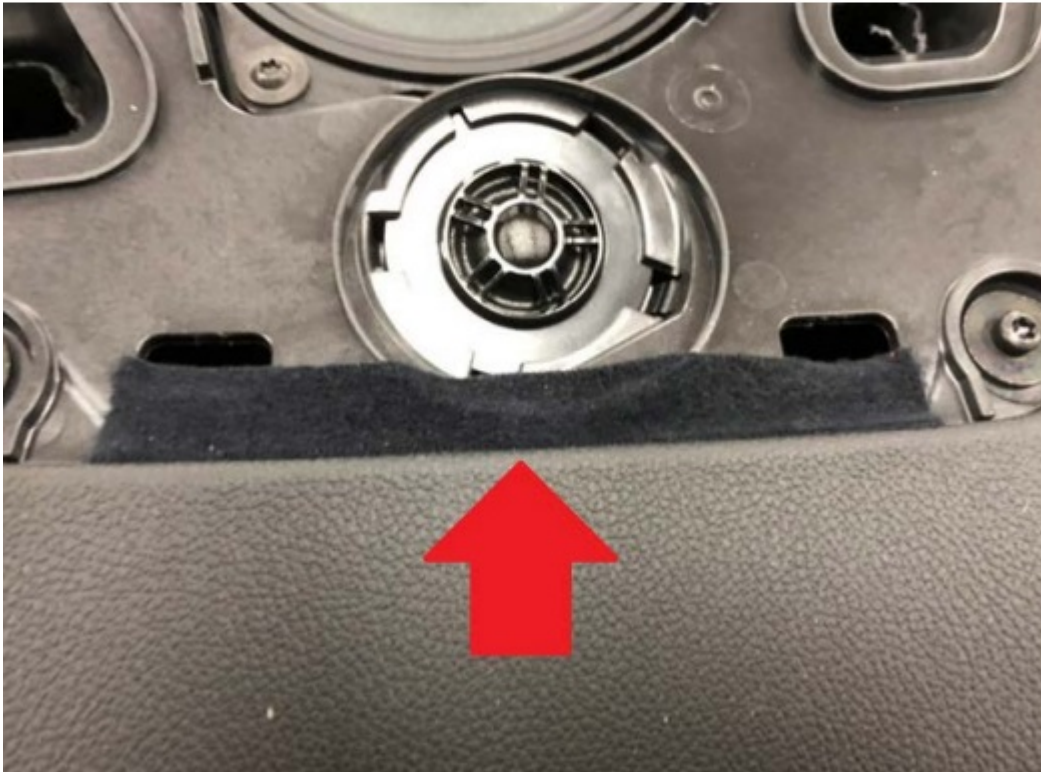
A rattle noise is present from the dashboard's center speaker cover. This may only occur during phone calls, or with certain volumes/tones of music.

Interference between the dashboard speaker cover and the dashboard.

Insulate the speaker cover from the dashboard.

2. Apply any appropriately sized felt strips in the positions shown in the photo below:
