SIB 51 15 20

2020-04-17

WIND NOISE FROM ENGINE BULKHEAD

E-Series	Model Description
G07	X7 Sports Activity Vehicle

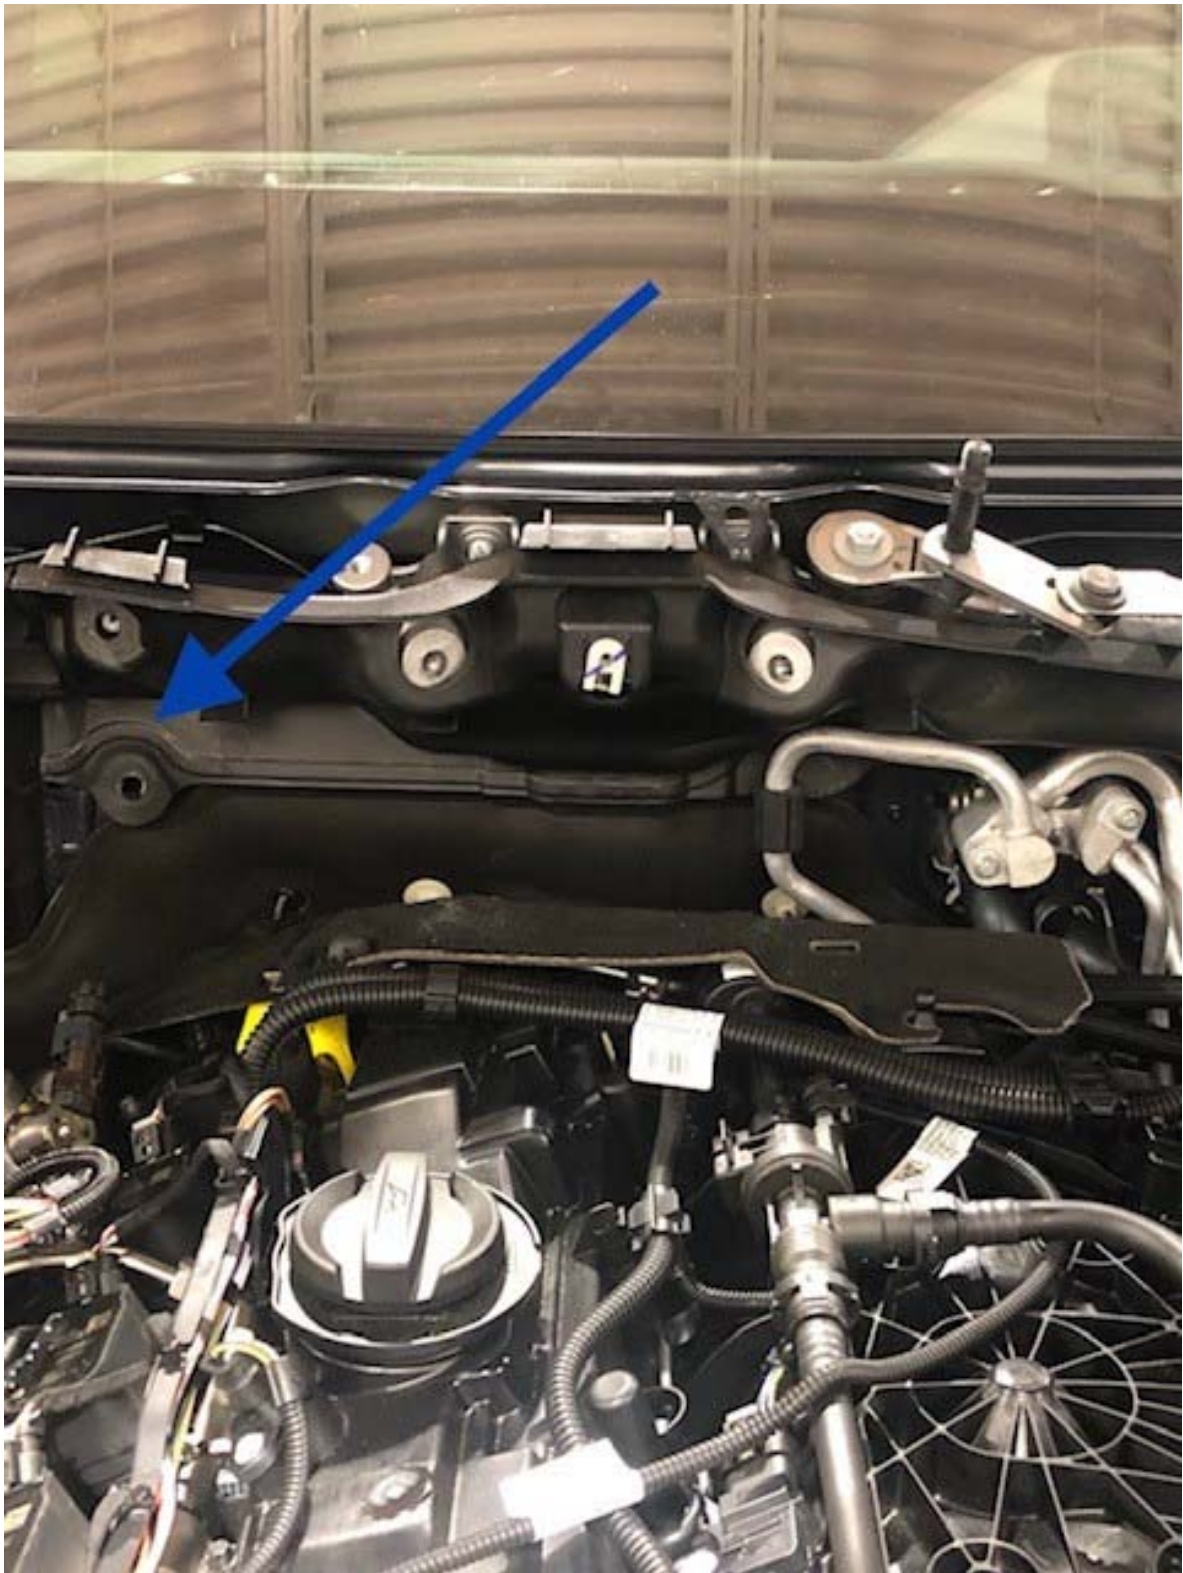
Improper sealing of the engine bulkhead trim.

1. Remove the engine bulkhead trim. Gain access for removal by removing the windshield panel cover, REP 51 13 116 "Removing and installing windshield panel cover".
2. Reference the photo below for the location of potential deformed seal:

3. With bulkhead trim removed, inspect the rubber sealing surface. Is the seal deformed?

4. Using butyl cord, reseal the bulkhead trim and completely reassemble the vehicle.
