SIB 51 16 20

WIND NOISE FROM WINDSHIELD SIDE TRIM

E-Series	Model Description
G05	X5 Sports Activity Vehicle
G07	X7 Sports Activity Vehicle

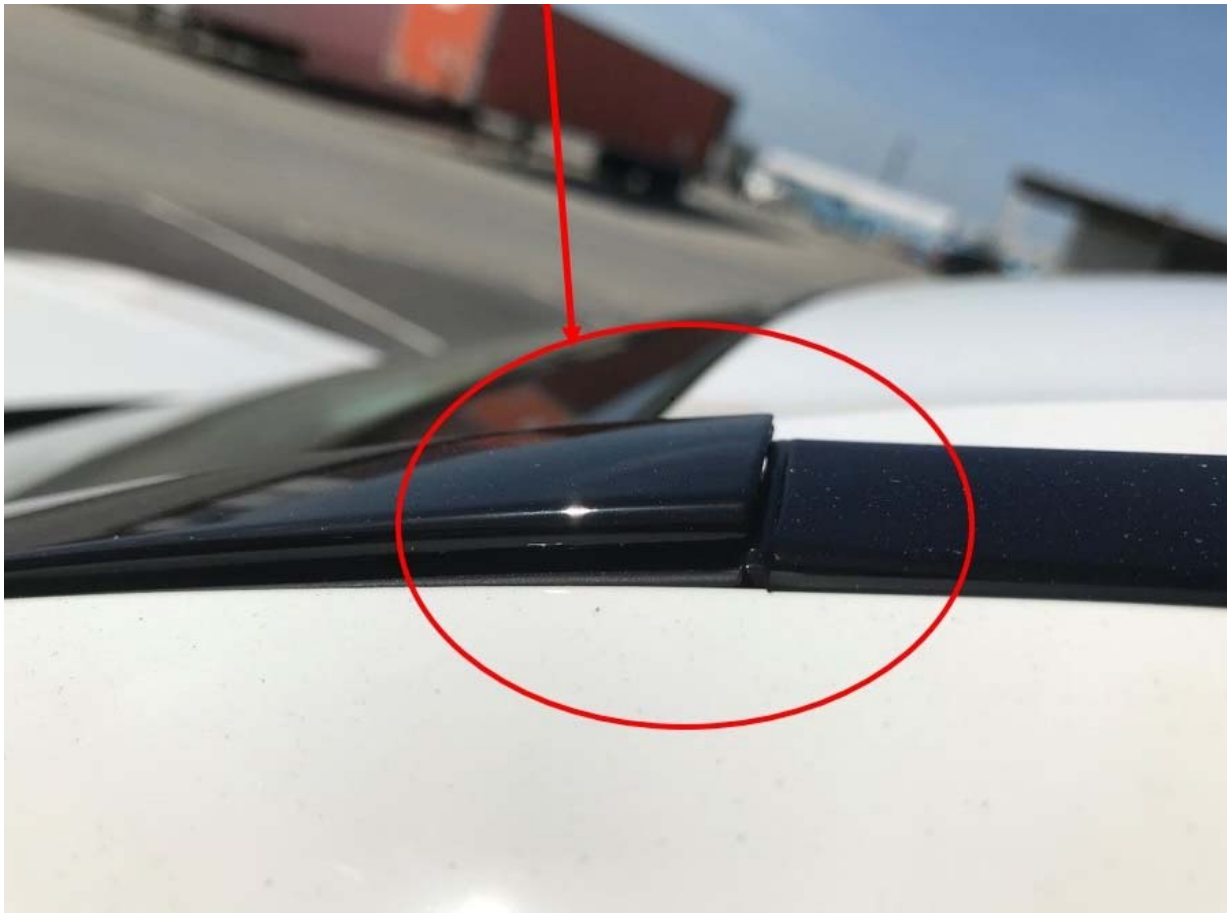
A wind noise from the windshield area is present while driving, caused by a separation of the windshield side trim (circled) on one or both sides.

Improper bonding of the side windshield trim during production.

Replace one or both sides of the windshield trim.

Replace the affected side window trim following repair instructions REP 51 31 030 “**Removing and installing/replacing the gutter strip on the windshield on the left or right**”.
