<b>DTC (Code)</b> SPN 100 FMI 1 // P0524 - 00 <b>Codigo:</b>	<b>Bulletin:</b> RD18-002 <b>Date Fecha:</b> June 11, 2018
<b>Description:</b> See below for fault code description(s)	
<b>Application:</b> US10 – US20 Emissions

**General Information**

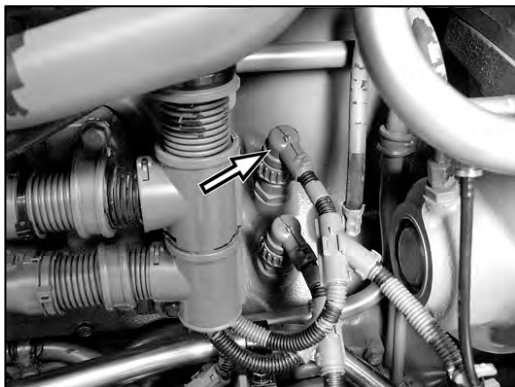
DTC	Description	Possible Cause	Possible (Observable) Symptoms
SPN 100 FMI 1 // P0524 - 00	Engine Oil Pressure Too Low	<ul style="list-style-type: none"> <li>• Low engine oil level (EOL)</li> <li>• Contaminated oil, slow flowing or too thin</li> <li>• Reduction valve</li> <li>• Worn oil pump</li> <li>• Engine oil pressure (EOP) sensor</li> <li>• Oil leakage</li> </ul>	<ul style="list-style-type: none"> <li>• Low Power</li> <li>• Reduced engine output and engine switch-off if the vehicle speed falls below 3 km/h (2 mph) when engine protection is chosen in the data set</li> </ul>

1. Turn the vehicle main electrical switch off.
2. Open the service hatch.
3. Disconnect the electrical connector.
