**Bulletin:** RD18-002  
**Date Fecha:** August 18, 2018

**Description:** Exhaust Gas Temperature Sensor Circuit Range/Performance  
Bank 1 Sensor 2 - Signal plausibility failure  
**Application:** US13 – US20 Emissions

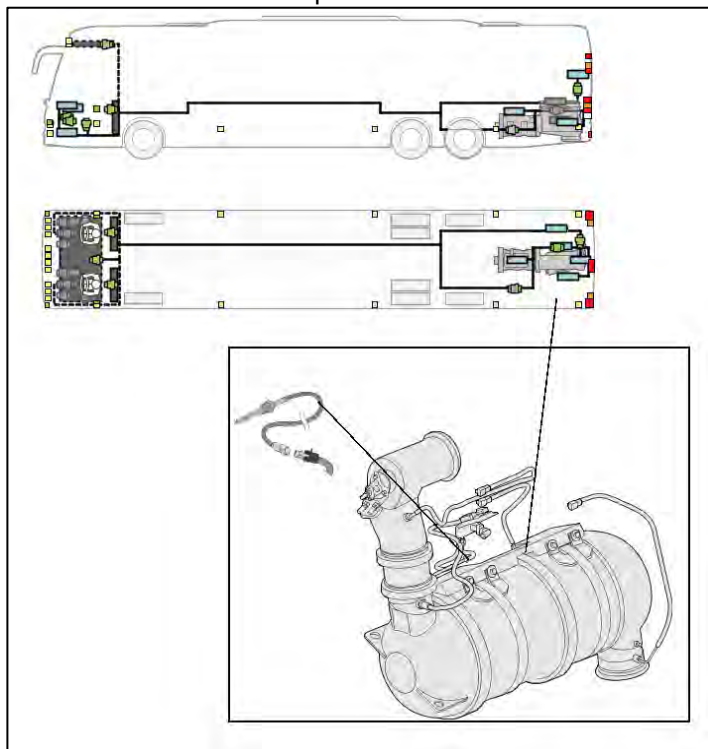
8. Remove the defective temperature sensor.

1. Clean the exhaust temperature sensor contact surface.
2. Install the replacement exhaust temperature sensor.
3. Reconnect the wiring harness connector to the exhaust temperature sensor and install clamps.
4. Secure the wiring harness with cable ties.
5. Reconnect all previously removed cables to the negative (ground) battery terminals.
6. Start the engine and check for function and leaks.
7. Connect Tech Tool to the vehicle. Use Guided Diagnostics to read and clear any diagnostic trouble codes (DTCs).
8. Install insulation, if removed.
9. Close the battery compartment access doors.
10. Close the rear engine service doors.
