<b>DTC (Code)</b> P0402 - 00 <b>Codigo:</b>	<b>Bulletin:</b> RD18-002 <b>Date Fecha:</b> August 12, 2018
<b>Description:</b> Engine Exhaust Gas Recirculation Differential Pressure - Mechanical system not responding properly	
<b>Application:</b> US13 - US20 Emissions

EGR Differential Pressure Sensor, Replacement

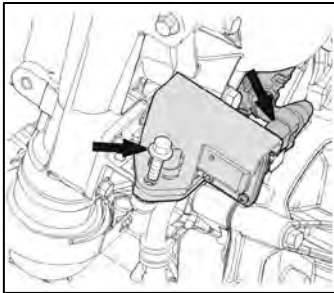
**Old Style EGR  
Differential Pressure**

3. Disconnect the wiring harness lead from the connector terminal on the EGR pressure differential sensor. Loosen and remove the mounting bolts and remove the EGR pressure differential sensor from the venturi tube. *Note: Install new sealing rings when replacing the sensor.*

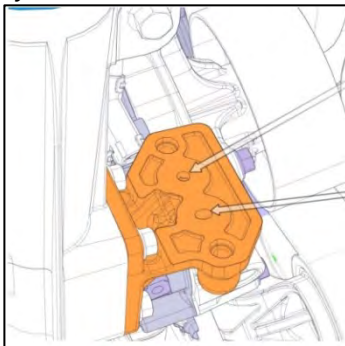
**New Style EGR  
Differential Pressure**

4. Clean the sealing surface where the EGR differential pressure sensor mounts into the EGR venturi tube. Ensure that the ports of the venturi tube are fully open and free of debris. *Note: If the ports to the EGR differential pressure sensor are clogged check the entire EGR system for clogging and debris. Clean the system as needed.*

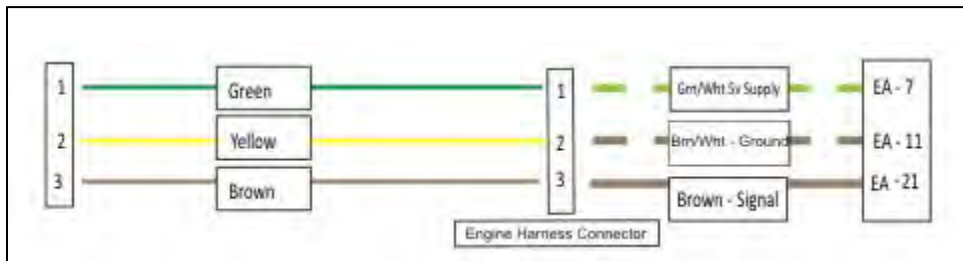
*Note: The new engine harness connector pin locations when replacing old style EGR differential pressure sensor with the new style sensor in kit are:*

- Pin 1 — Green/White
- Pin 2 — Brown/White
- Pin 3 — Brown

1. Clip applicable cable ties and remove P-clamps securing the EGR differential pressure sensor harness leg.
2. Use extractor tool (part number 9812483) in kit 88890037 to relocate the engine harness connector pins.  
Special tools: 9812483
3. Connect the EGR differential pressure sensor jumper harness to the engine harness.
