<b>DTC (Code)</b> P10CE-97 <b>Codigo:</b>	<b>Bulletin:</b> RD18-002 <b>Date Fecha:</b> June 13, 2018
<b>Description:</b> Reductant Return: No Flow Detected - Component or System Operation Obstructed or Blocked	
<b>Application:</b> US13 – US20 Emissions

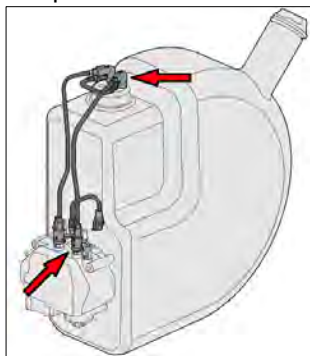
Before replacing the DEF Pump Unit please check for damaged return hoses and connectors.

1. Disconnect and clean the aftertreatment DEF lines between the DEF tank and the DEF pump using water and compressed air. If the line is broken then it will have to be replaced.

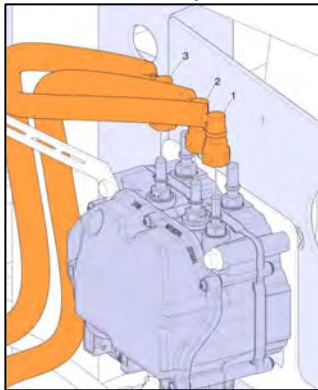
1. DEF Outlet Line
2. DEF Backflow Line
3. DEF Inlet Line

4. Open right rear engine service door.
5. Connect the coolant extractor to the drain fitting at the bottom of the radiator and drain the coolant. Note: An alternate method is to connect the coolant drain hose to the drain fitting and drain the coolant into a suitable container. Special tools: 85112740, 9996049

6. Place a suitable container under the DEF tank to catch fluid that may drain from the pump. Note: Use protective equipment and an approved suitable container. Dispose of DEF according to local regulations.

7. Mark the DEF lines before removal. Remove the DEF inlet, backflow and outlet lines from the pump. Place protective caps on the DEF lines. Note: For information on the handling of DEF, refer to "General Safety Practices", Group 20. Note: If inlet and backflow lines are switched, the system will not start.

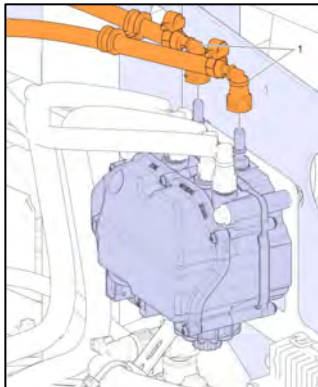
1. Coolant Lines

8. Remove the inlet and outlet coolant lines from the pump. Place protective caps on the coolant lines.

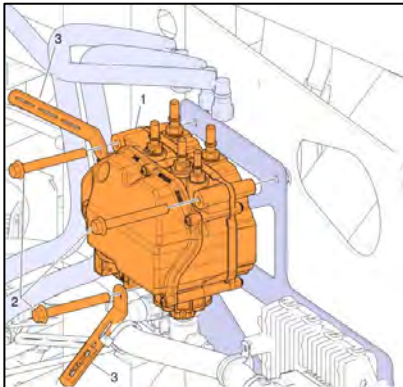
1. DEF Pump
2. Fasteners
3. Brackets

10. Remove the fasteners, brackets and DEF pump from the mounting bracket.
