<b>DTC (Code)</b> P2084-64 <b>Codigo:</b>	<b>Bulletin:</b> RD18-002 <b>Date Fecha:</b> August 18, 2018
<b>Description:</b> Exhaust Gas Temperature Sensor Circuit Range/Performance Bank 1 Sensor 2 - Signal plausibility failure	
<b>Application:</b> US13 - US20 Emissions

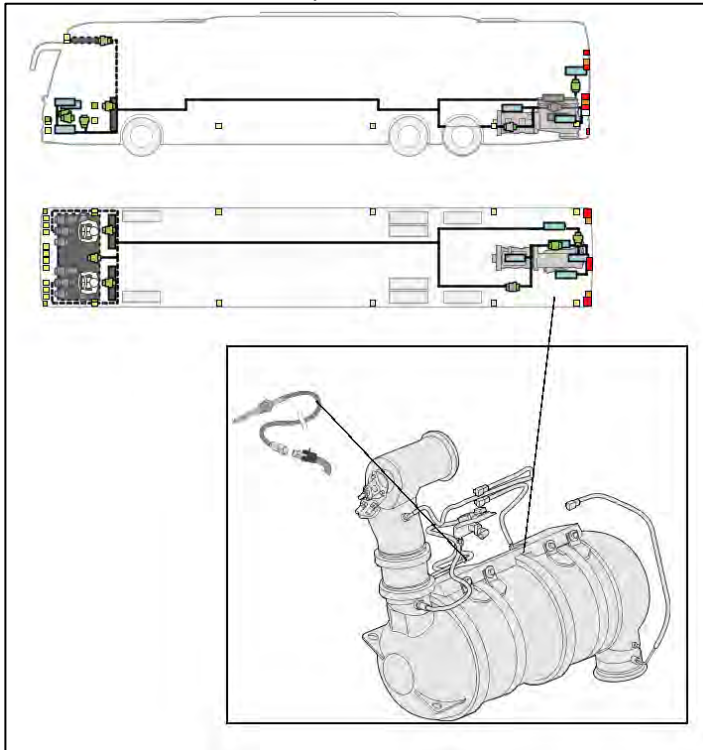
8. Remove the defective temperature sensor.

1. Clean the exhaust temperature sensor contact surface.
2. Install the replacement exhaust temperature sensor.
3. Reconnect the wiring harness connector to the exhaust temperature sensor and install clamps.
4. Secure the wiring harness with cable ties.
5. Reconnect all previously removed cables to the negative (ground) battery terminals.
6. Start the engine and check for function and leaks.
7. Connect Tech Tool to the vehicle. Use Guided Diagnostics to read and clear any diagnostic trouble codes (DTCs).
8. Install insulation, if removed.
9. Close the battery compartment access doors.
10. Close the rear engine service doors.
