DTC (Code) P242A-15 Codigo:	Bulletin: RD18-002 Date Fecha: July 9, 2018
Description: Exhaust Gas Temperature Sensor Bank 1 Sensor 3 - Circuit Short To Battery or Open	
Application: US13 – US20 Emissions

Exhaust Gas Temperature (EGT) Sensor, Replacement

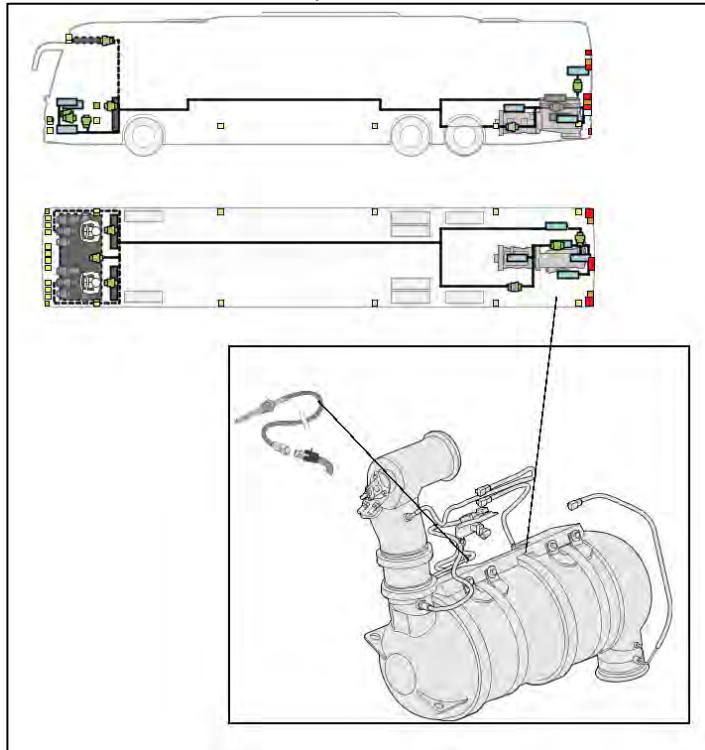
DTC	Description	Possible Cause	Possible (Observable) Symptoms
P242A-15	Exhaust Gas Temperature Sensor Bank 1 Sensor 3	<ul style="list-style-type: none"> • Connector • Open circuit, Signal wire • Open circuit, Ground wire • Short circuit to voltage supply, signal wire • Wiring harness between component connector and electronic control unit (ECU) connector • Exhaust Gas Temperature (EGT) Sensor • Aftertreatment Control Module (ACM) 	Regeneration not possible

8. Remove the defective temperature sensor.

1. Clean the exhaust temperature sensor contact surface.
2. Install the replacement exhaust temperature sensor.
3. Reconnect the wiring harness connector to the exhaust temperature sensor and install clamps.
4. Secure the wiring harness with cable ties.
5. Reconnect all previously removed cables to the negative (ground) battery terminals.
6. Start the engine and check for function and leaks.
7. Connect Tech Tool to the vehicle. Use Guided Diagnostics to read and clear any diagnostic trouble codes (DTCs).
8. Install insulation, if removed.
9. Close the battery compartment access doors.
10. Close the rear engine service doors.
