Technical Service Bulletin

40 Clicking noise from wheel bearing

40 20 05 2024318/9 May 13, 2020. Supersedes Technical Service Bulletin Group 40 number 17-74 dated July 19, 2017 for reasons listed below.

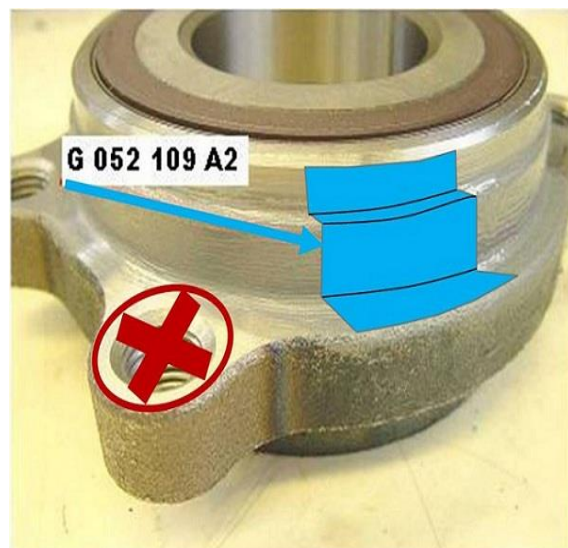
Microscopic movements between the wheel bearing and wheel bearing housing may cause the noise (front left and/or front right bearing can be affected).

Figure 1. Area to apply paste.

1. On the affected side(s), remove any corrosion and dirt from the wheel bearing housing and the wheel bearing.
2. Using a brush, apply a thin coat of paste part number G 052109A2, using about .21 ounces or 6 grams (roughly 1/20) from the tube on the wheel bearing housing as shown (Figure 1). Make sure not to apply any paste on the threads.
