Daimler Trucks North America LLC

This documentation applies to New Cascadia vehicles built in 2019.

Walmart Transportation Draglink Inspection.

This inspection applies to the 20-XXXX units only.

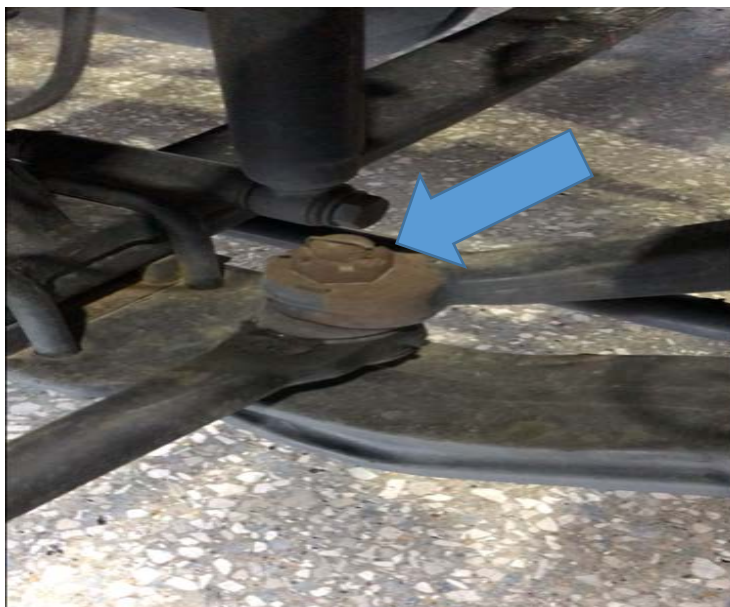
- 1- The technician will inspect the draglink for a loose castlenut at the steering arm connection point.
- 2- The video in the standard job notes is for reference of a loose castlenut.

- 3- If the castlenut does not appear to be loose, the cotter pin is in place and there is no movement from the draglink /steering arm connection point when the steering wheel is moved back and forth, remove the cotter pin and torque the castlenut to 239 ft. lbs. If the new cotter pin does not align, once castlenut is torqued, continue to tighten the castlenut to achieve alignment. DO NOT loosen the nut to allow for alignment of the cotter pin.

- 4- If movement is found at the draglink/steering arm connection point, the draglink and steering arm will need to be replaced. Refer to section 46.06.100 for the draglink replacement in the New Cascadia Workshop Manual. Refer to Meritor Maintenance Manual 2 for Front Non-Drive Steer Axles, section 10 for arm replacement. The 239 ft. lbs. of torque and cotter pin alignment procedure will still apply to the castlenut for the draglink, if replaced.
