NUMBER: 23-014-20

Split/Crack of Metal Body Side Door Check Strap

RAM ProMaster

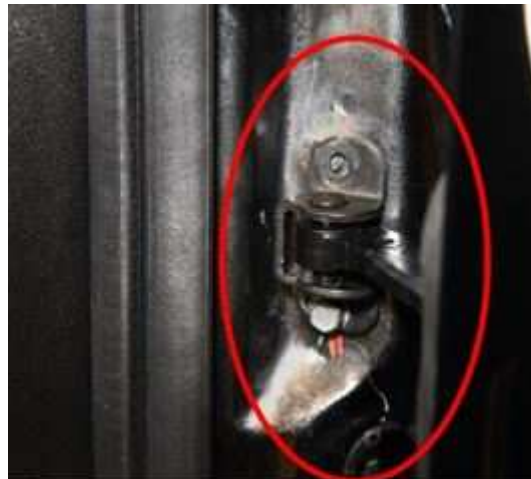
Fig. 1

The customer may notice a metal split or crack on the body side on either the driver or passenger side of the door check strap area (Fig. 1).

Check Strap Area Cracking

A step by step service repair is available. Refer to the detailed service procedures available in DealerConnect> Service Library>Collision Info under: 31 - Collision Information / Standard Procedure> Hinge Pillar Repair With Full Service Parts.
