NUMBER: 08-037-20

DATE: March 12, 2020

UAV and UCV Radio Enhancements

2019 - 2020 (WK) Jeep Grand Cherokee

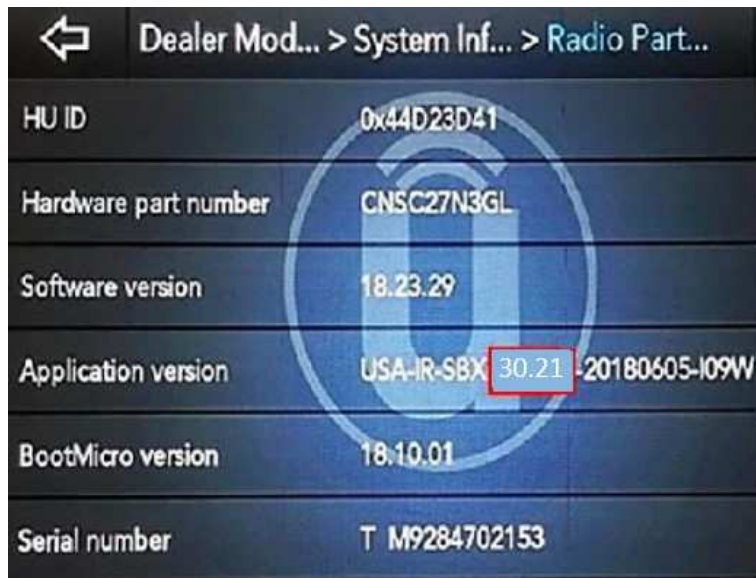
Fig. 1
Radio Software Level Screen

3. Is the radio software level "Application Version" lower than 28.0? (Fig. 1) ?
 - YES >>> This bulletin does not pertain, Normal diagnostic should be performed.
 - NO >>> The radio software needs to be updated. Back out of Dealer Mode and proceed to [Step 1](#) of the Repair Procedure.
