SIL 742

Service Information Letter

Units Affected: AT37-G, AT40-G, AT40M, AT41M, and AT41ME units on Dodge diesel chassis equipped with JEMS systems, built from January 2018 to June 2019 (see attached list)

Air Conditioning Line Inspection

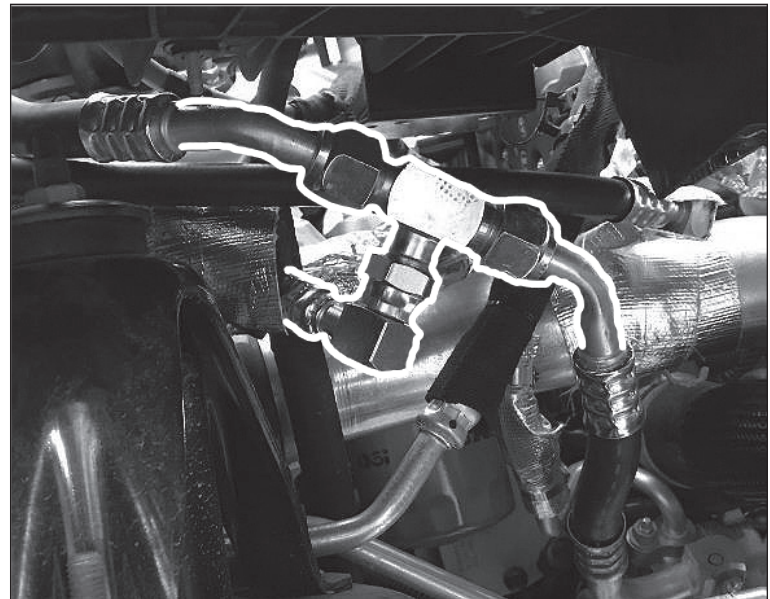
Figure 2 — Air Conditioning Hoses and Tubing (outlined in white)

7. Inspect the condition and routing of the air conditioning hoses along the curb side of the chassis (refer to Figure 2).
8. Look for interference and damage to the hoses and fittings where the air conditioner hoses are close to other chassis components (refer to Figures 3, 4 and 5). Use the Decision Chart on page 4 to assist in determining what action is required.

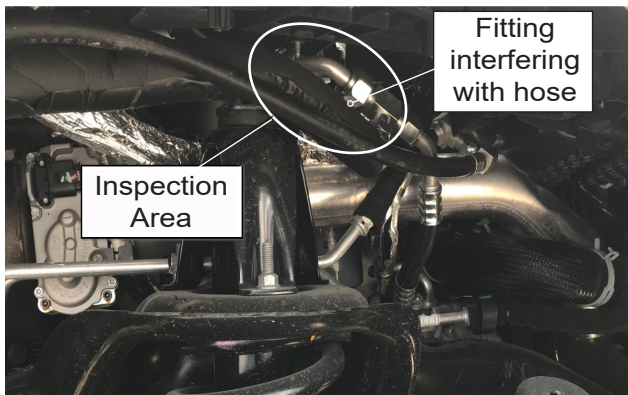
Altec has discovered that the routing of the air conditioning lines on some units causes the hoses or fittings to interfere with other components in the engine compartment. This can result in hose or fitting damage which can lead to air conditioning system failure.

Figure 2 — Possible Interference

- If there is evidence of hose interference, order the AC Repair and Routing Kit, part number 991071498. Reroute and protect the air conditioner hose(s) to eliminate the interference, if possible. Hold them in position using cable ties.

- If there is evidence of air conditioner hose interference that requires the loosening of hose fitting(s) to move the air conditioner hoses, order the AC Repair and Routing Kit, part number 991071498.

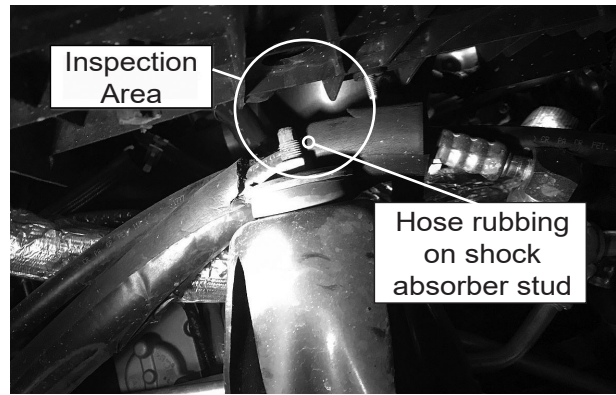
Figure 3 — Possible Hose Damage

- If there is evidence of air conditioner hose or fitting damage that requires the loosening of fitting(s) to replace air conditioner hoses, order AC Connection Repair Kit, part number 990877593 and the AC Repair and Routing Kit, part number 991071498.

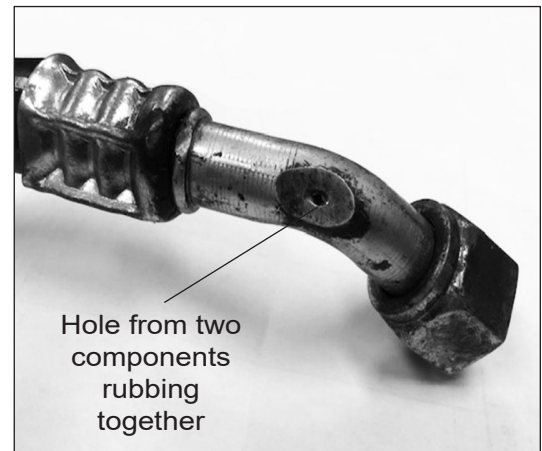
Figure 4 — Damaged Hose
