JLRTB02040NAS1
TECHNICAL BULLETIN
26 MAY 2020

Heated Tailgate Window Inoperative

MODEL:	MODEL YEAR:	VIN:	ASSEMBLY PLANT:
I-PACE (X590)	2019 Onwards	F60094 Onwards	Graz (Austria)

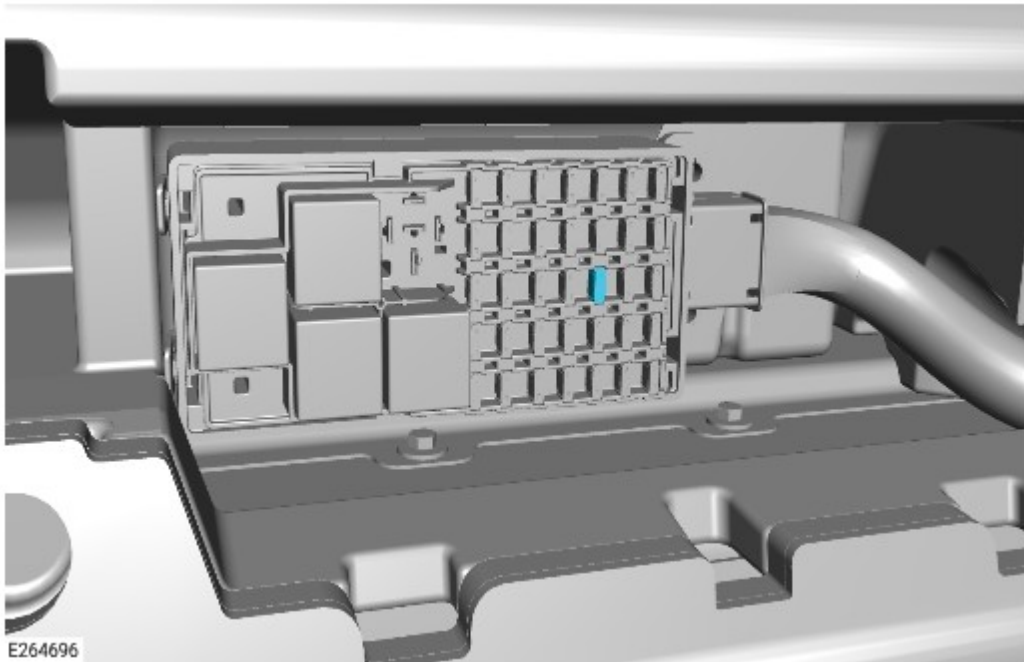
4.

The heated tailgate window is inoperative when the switch is in the ON position. Further investigation has found that fuse F17 in the Passenger Junction Box (PJB) has blown.

Operating current higher than expected.

Remove and discard fuse F17 from the PJB.

- ■ Install the new 30A mini fuse in F17 of the PJB.
