## STAR ONLINE PUBLICATION

**Case Number:** S2023000020

**Symptom/Vehicle Issue:** Tick Noise From A-pillar Front Power Top Side Rail

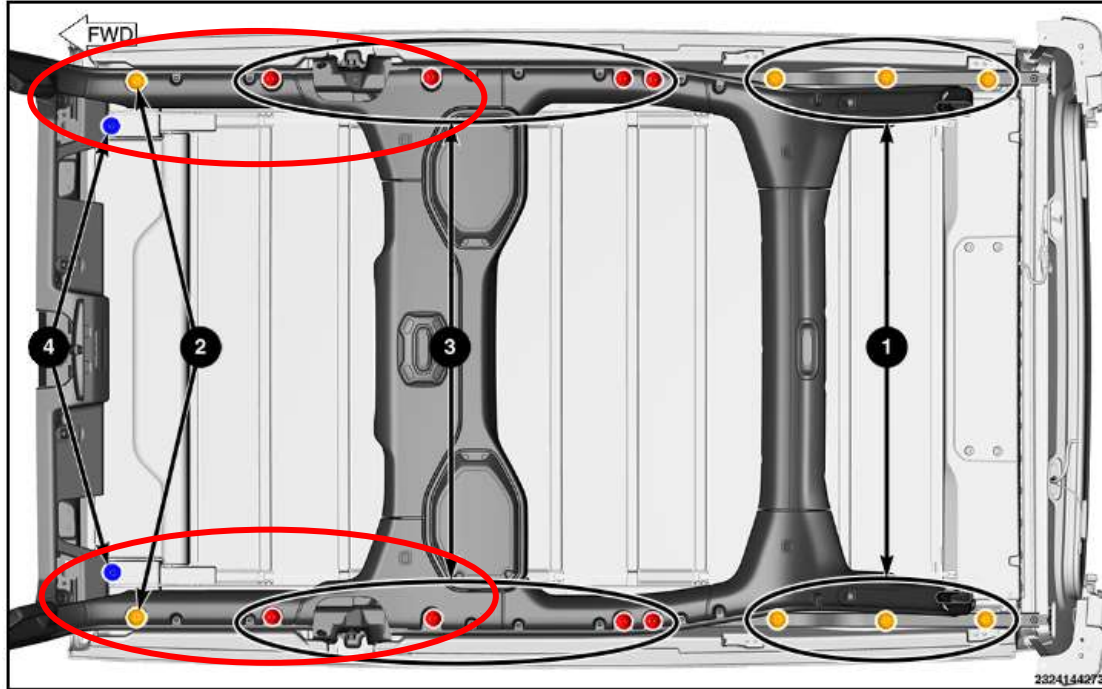
**Discussion:** If a tick or click noise is heard from the Sky One power roof system above the front row seat occupants heads see the below procedure to add anti-squeak tape.

1. Power the roof full open.
2. Remove the front four bolts on each side of the assembly (to loosen front of rail to body to gain access to Torx head fasteners between side rail and track)
  - a) Remove the front “blue” screws (#4 below) that secure the front of the power top assembly.
  - b) Remove the front “gold” screws (#2 below) at the front door openings.
  - c) Remove front two “red” screws in oval (#3 below)

**NOTE:** The screws that anchor the power top assembly to the frame of the vehicle are different lengths. Damage can occur if a long screw is placed in a short hole. Refer to the illustration for proper screw locations.
