STAR ONLINE PUBLICATION

Case Number: S2018000003

Symptom/Vehicle Issue: Customer complaint may include MIL/Check Engine lamp on. Upon further inspection, fault code P219A - Bank 1 Air-Fuel Ratio Imbalance may be found in the powertrain control module (PCM) as pending, active, or stored. Other fault codes P1066, P1068, P106A, or P106C (Solenoid Valve Switch Off Time Out of Range) may also be stored. Customer may also complain about loss of power or engine running rough while P219A is active.

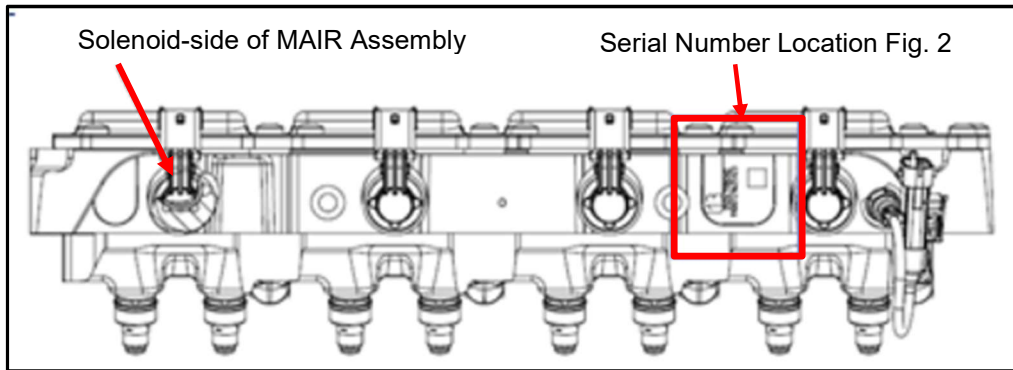
Fig. 1

1. Remove the valve cover (cylinder head cover) per published service instructions found in Service Library.
2. Once the MAIR is exposed, locate the serial number etched into the side of the MAIR. See Figures 1 and 2 below for location.

3. If the published diagnostic routine for the fault code listed above does not clearly lead to an engine hardware issue, and the MAIR on the engine was produced before the 10/04/19 clean point, the MAIR unit is suspect and should be replaced.
