STAR ONLINE PUBLICATION

Case Number: S1808000282

Symptom/Vehicle Issue: Customer complaint may include MIL/Check Engine lamp on, other driveability complaints. Upon further investigation, fault codes P0107- Map Sensor Circuit Low, P0108-Map Sensor Circuit High, P2172-High Airflow/Vacuum Leak Detected (Instantaneous Accumulation), P2173-High Airflow/Vacuum Leak Detected (Slow Accumulation) may be set in the powertrain control module (PCM).

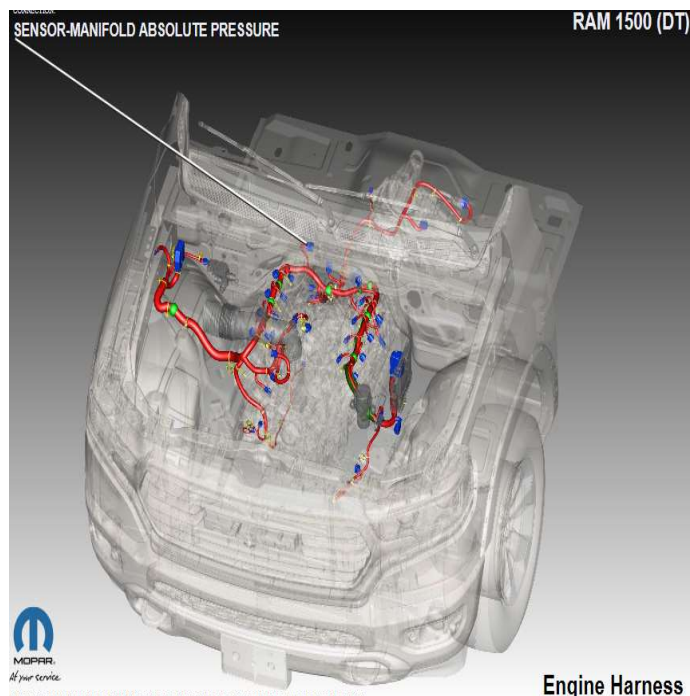
Example – 5.7 eng , Black 3 way connector.

Discussion: Inspect the map sensor connector terminals at the map sensor location for possible pushed out or spread terminals (wiggle connector while checking for reading change), replace the terminals as needed, repair kit connector/ terminals (Kit 68225153AA).
