STAR ONLINE PUBLICATION

Case Number: S2024000004

Symptom/Vehicle Issue: Customer Indicates Vehicle Has Poor Air Flow Through Demister (Side) Dash Vents

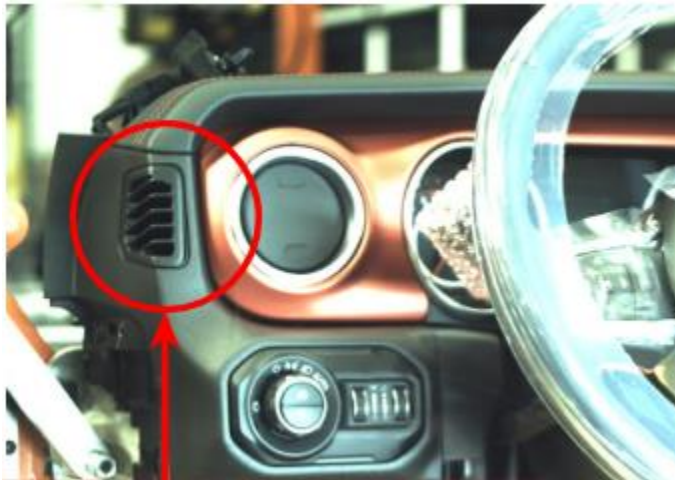
Diagnosis: This condition can be caused by a misalignment with the HVAC ducts causing the demister grill to become unseated and pop out of position.

Inspect the demister grill for proper position/installation. Remove the demister grill (side vent cap/cover) inspect the HVAC ducting for proper connections and ensure that it is fully seated and in place. After HVAC duct has been verified to be properly seated and in position, reinsert demister grill. If the demister grill shows visual damage and does not seat properly replace with new.

Verification: Reinstall the HVAC components and test for proper air flow out of the side vents.
